## **AQUACULTURE SUPPORT VESSEL APPRAISAL REPORT**

### **“SKIFF BARRETT”**

**REPORT #16128 - 1**

**DATE: September 2016**

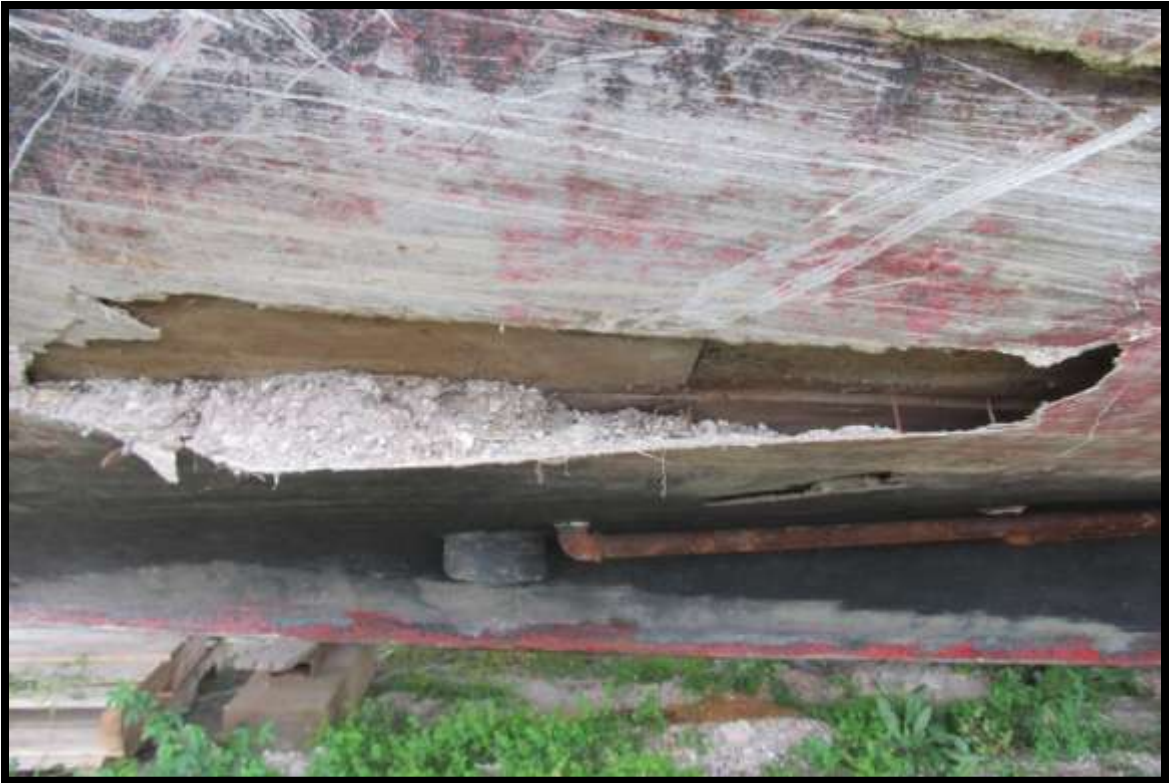
**PORT SIDE HULL DAMAGE**

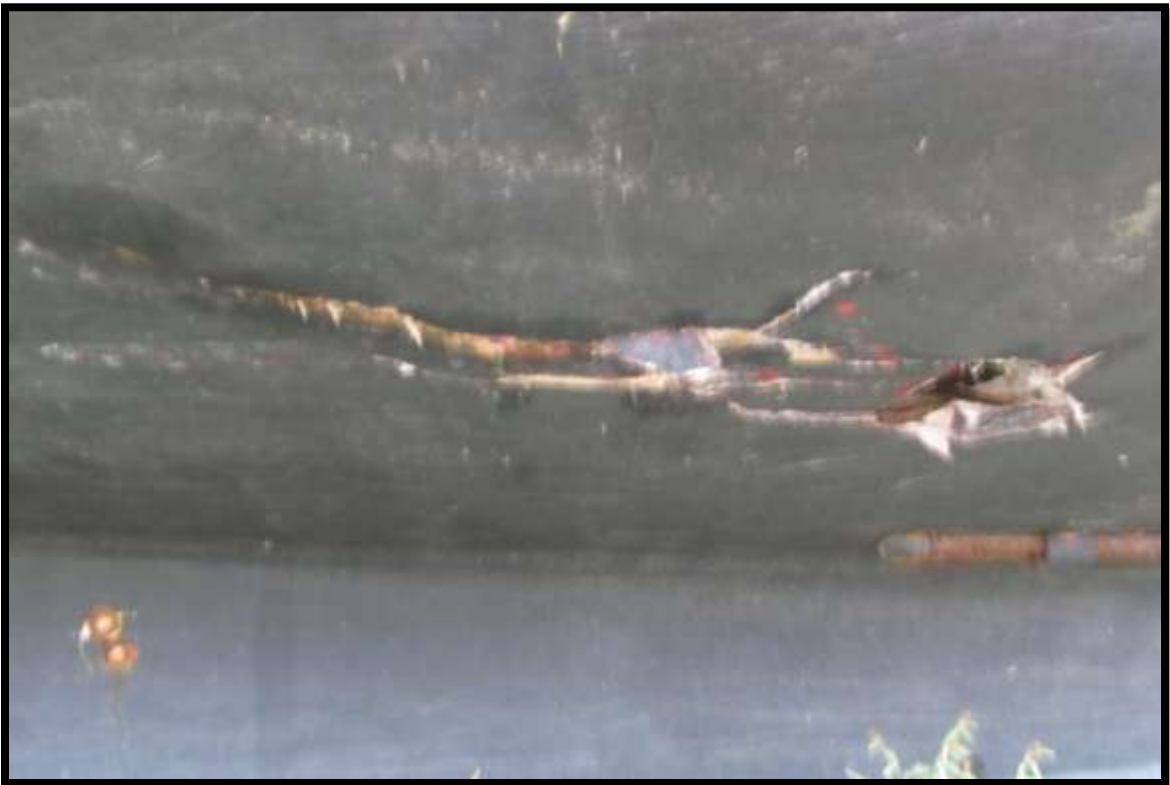
**STARBOARD SIDE HULL DAMAGE**

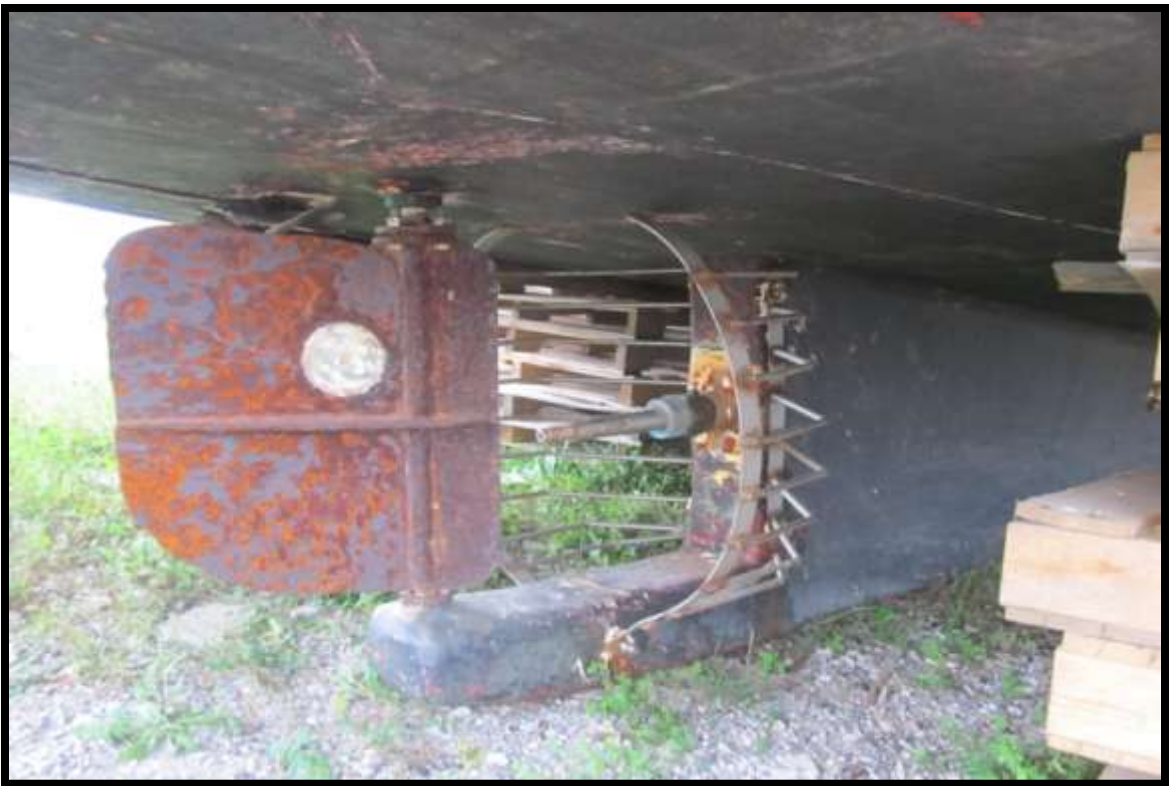
**STARBOARD SIDE AFT HULL/TRANSOM DAMAGE**
