# AQUACULTURE SUPPORT VESSEL APPRAISAL REPORT

**“K.C.”**

**COMPLETED BY: TRINAV MARINE DESIGN  
ST. JOHN'S, NL**

**REPORT # 16128 - 18**

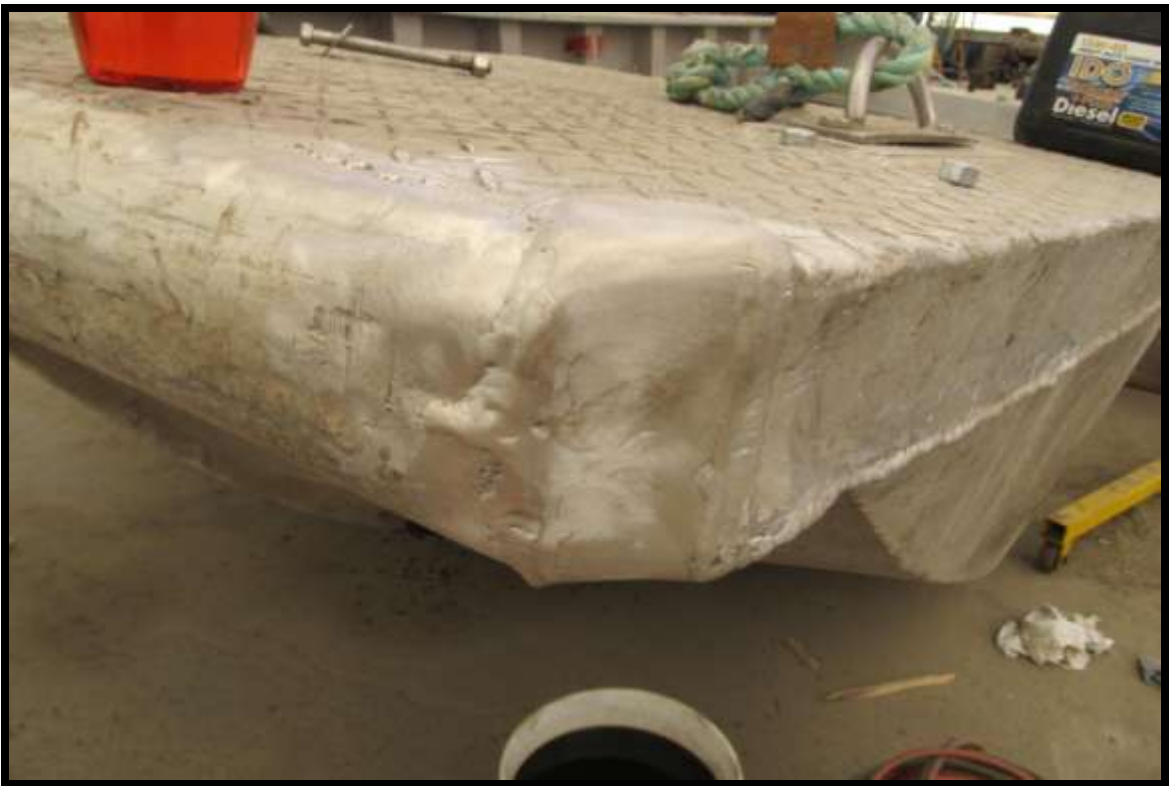
Vessel was surveyed at the storage/repair facility located in Conne River, NL. Due to the positioning of the vessel within the storage/repair facility, the hull bottom was unable to be surveyed. Above water hull (where visible) was found to be in fair to average visual condition. Minor damages were noted along the hull sides, bow, bulwarks and main deck plating. Evidence of previous repairs was also noted in the bow area.

**BOW REPAIRS**

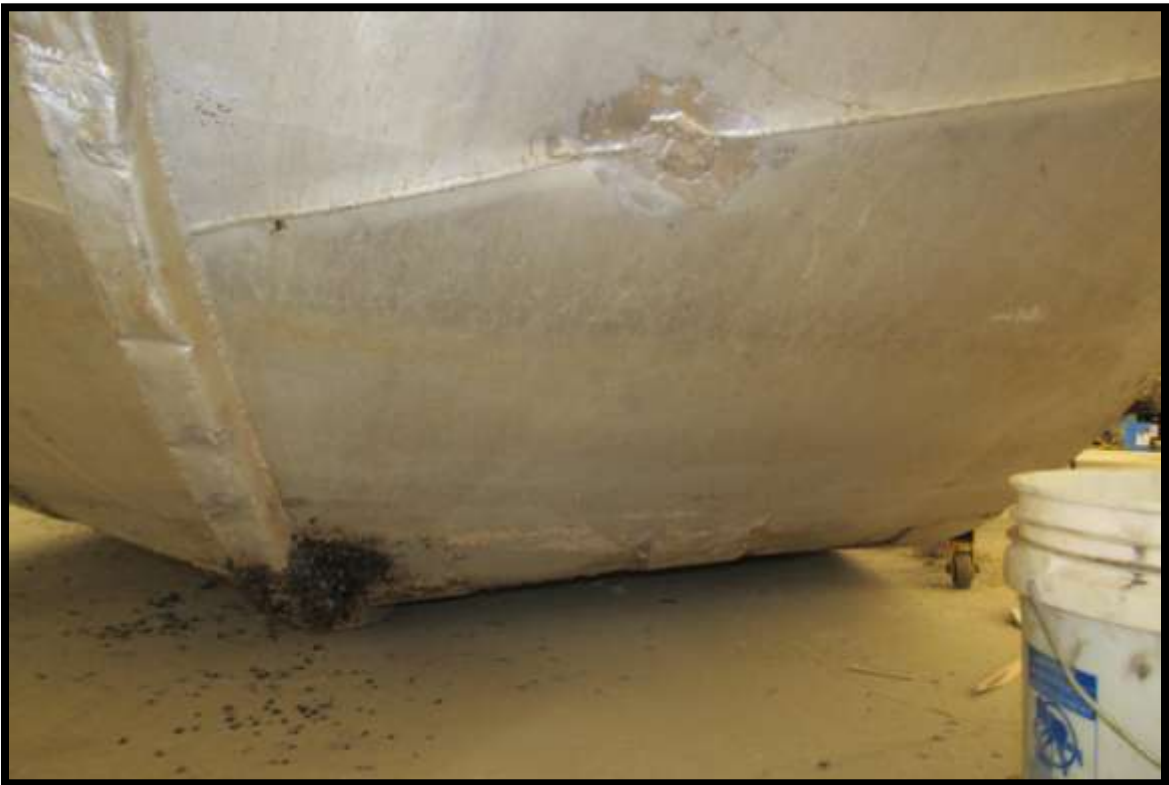
**BOW DAMAGES/REPAIRS**

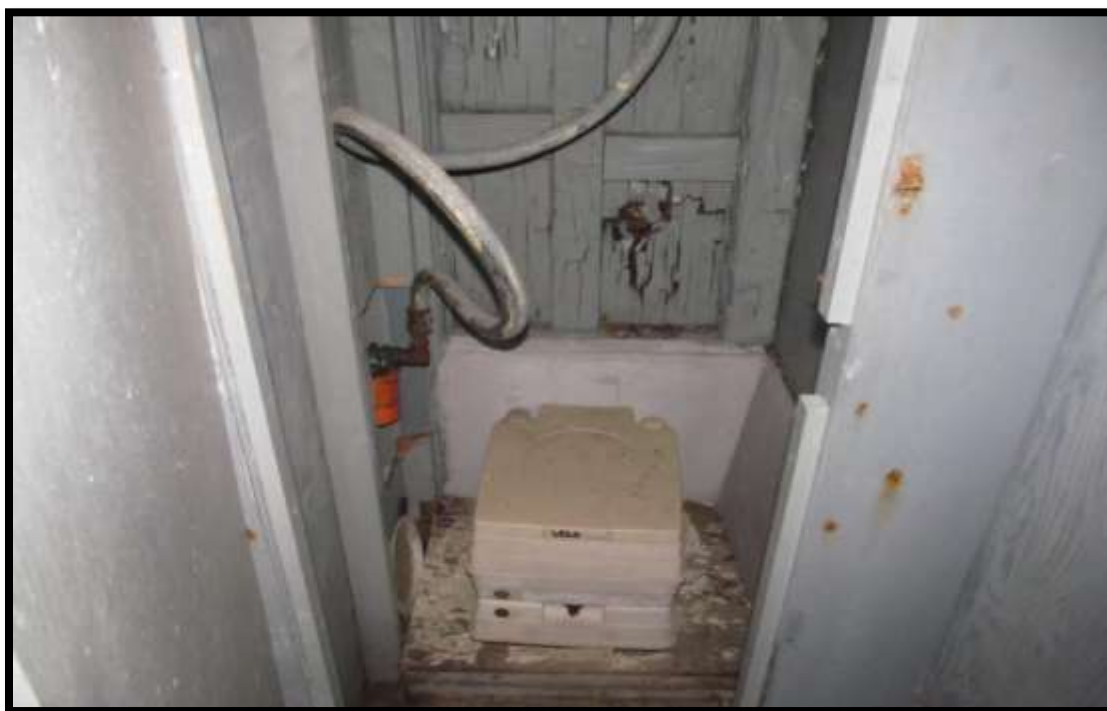
**MAIN DECK WASHROOM. EXTENSIVE ROT NOTED**

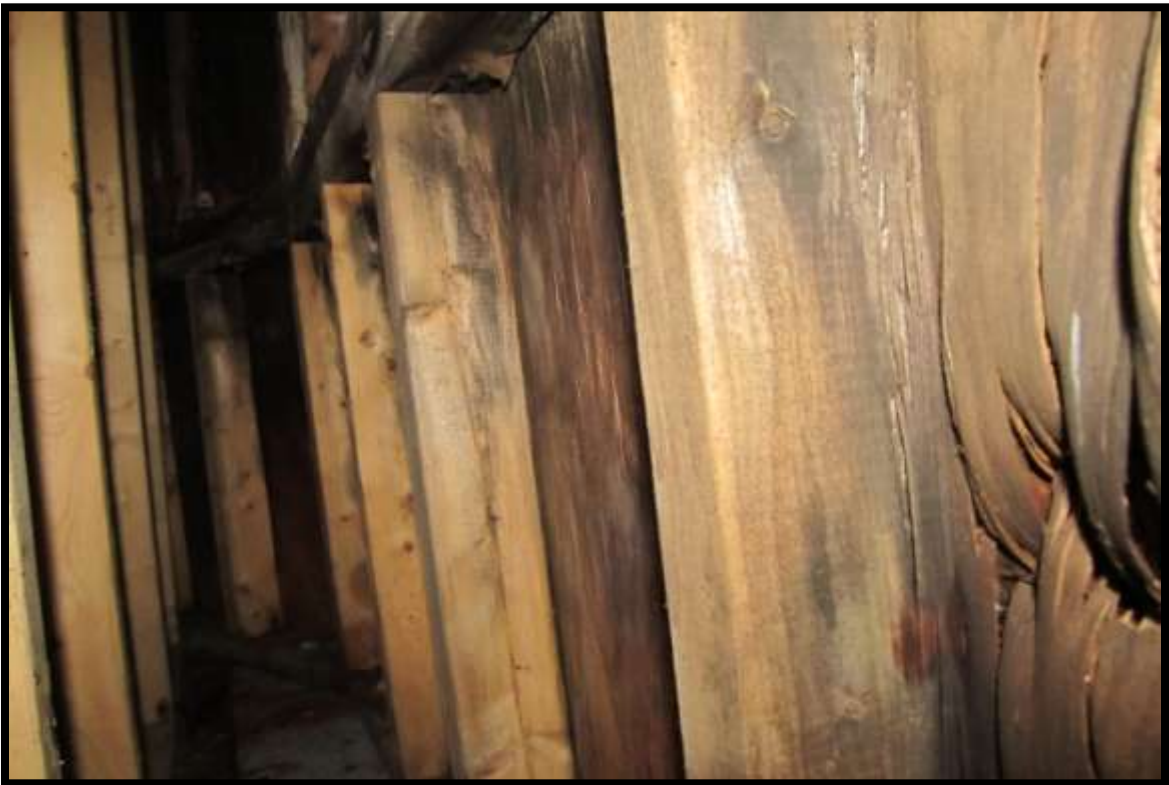
Since the vessel was afloat at the time of the survey, the exterior underwater hull was inaccessible. The exterior hull, decks, deckhouse/wheelhouse were all found to be in fair to poor visual condition. The vessels interior was also found to be in an overall fair visual condition. A moderate to extensive amount of rot was noted within the wheelhouse, deckhouse and main deck structure.

**WHEELHOUSE FRONT STRUCTURE. EXTENSIVE ROT NOTED**

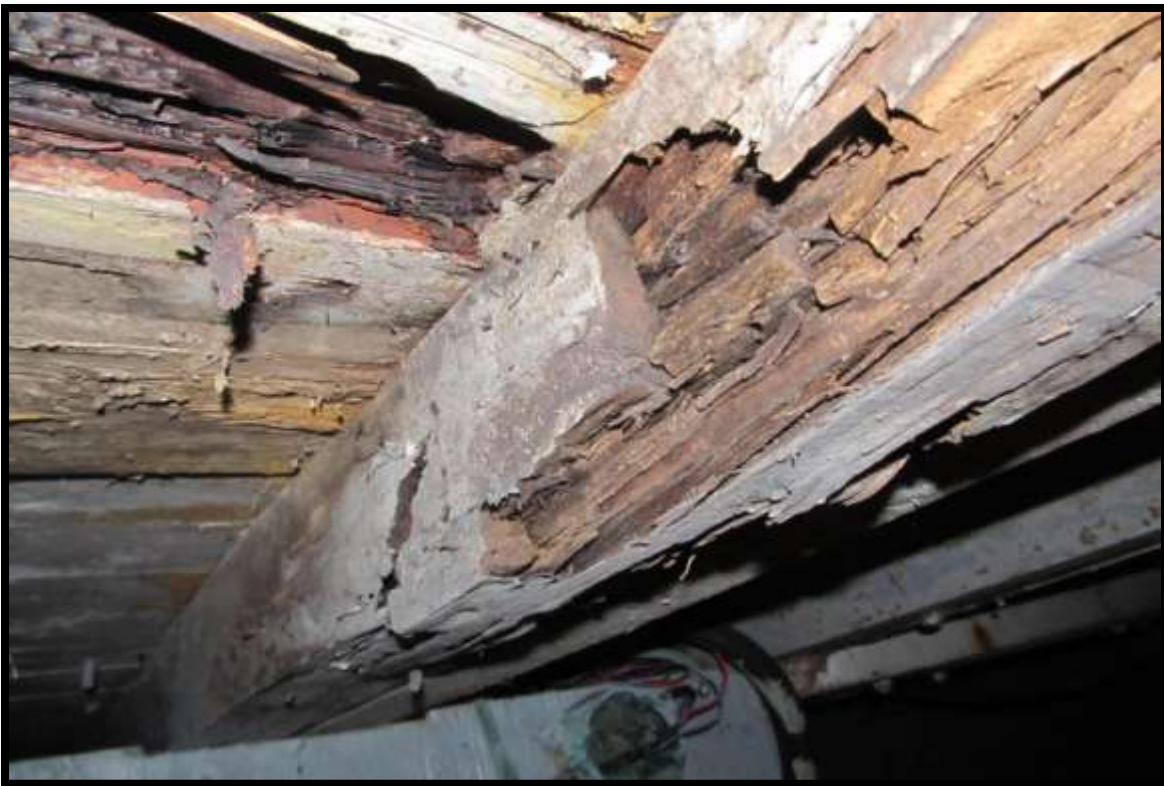
| <b><u>ITEM</u></b> | <b><u>COMMENTS / CONDITION</u></b> |
|---|---|
| <b>REMARKS:</b> Typical interior arrangement for vessels age and design. In general, the hull structure was found to be in fair visual condition where visible. Rot was evident on main deck beams and deckhouse structure. | |

**MAIN DECK STRUCTURE WITHIN FISH HOLD. EXTENSIVE ROT NOTED**

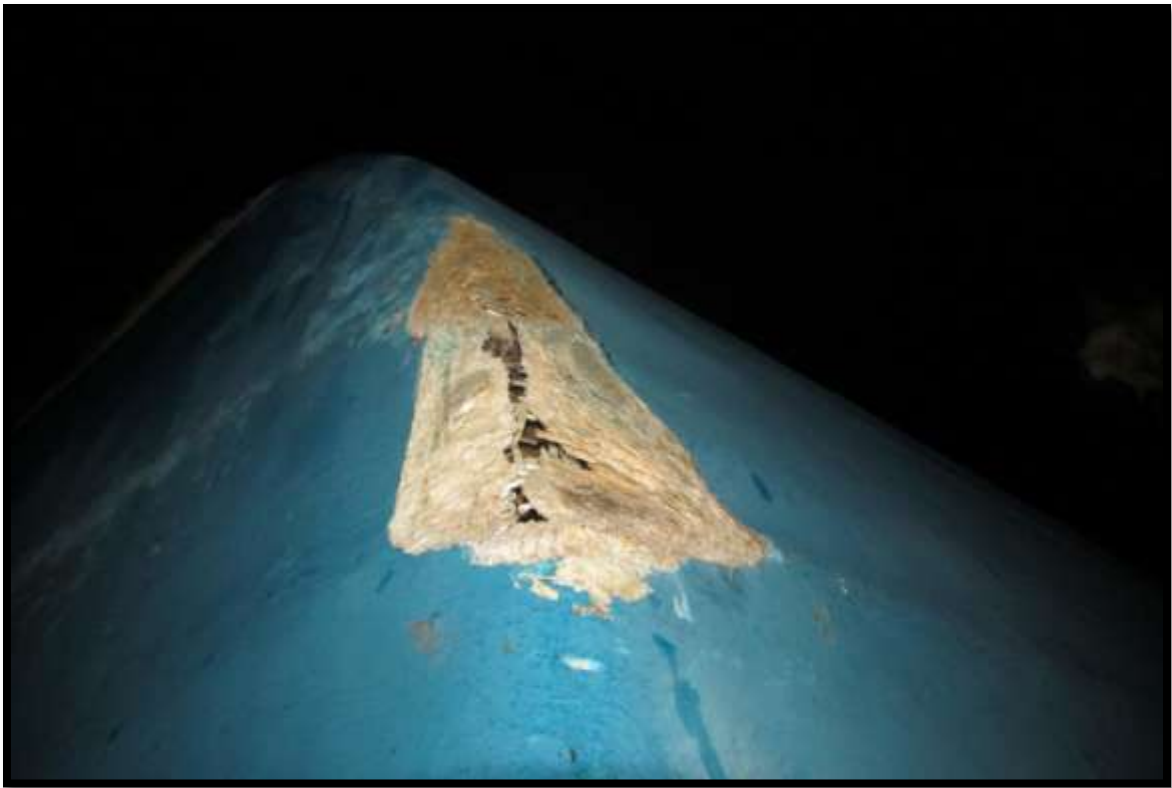
| <b><u>ITEM</u></b> | <b><u>COMMENTS / CONDITION</u></b> |
|---|---|
| <b>STERN</b> | Fiberglass over wood / average – damage noted on port & starboard corners |

**DAMAGE TO STARBOARD SIDE TRANSOM CORNER**

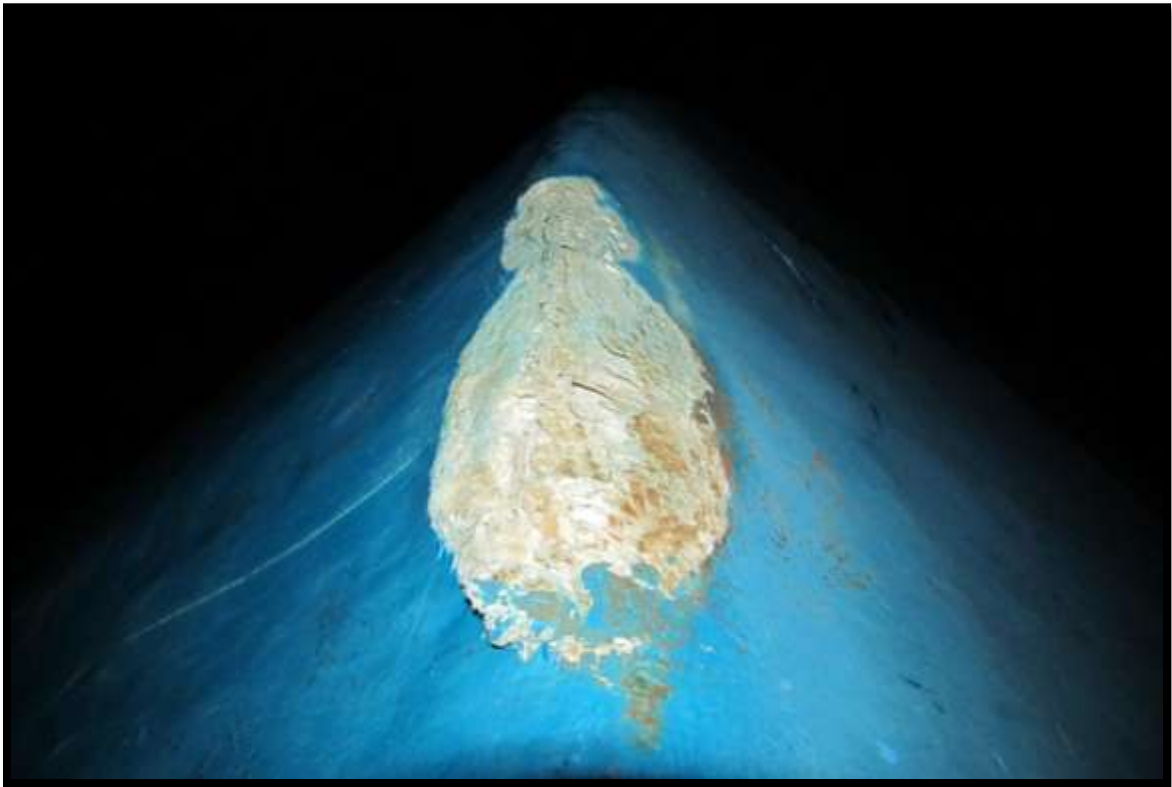
**DAMAGE TO PORT SIDE TRANSOM CORNER**

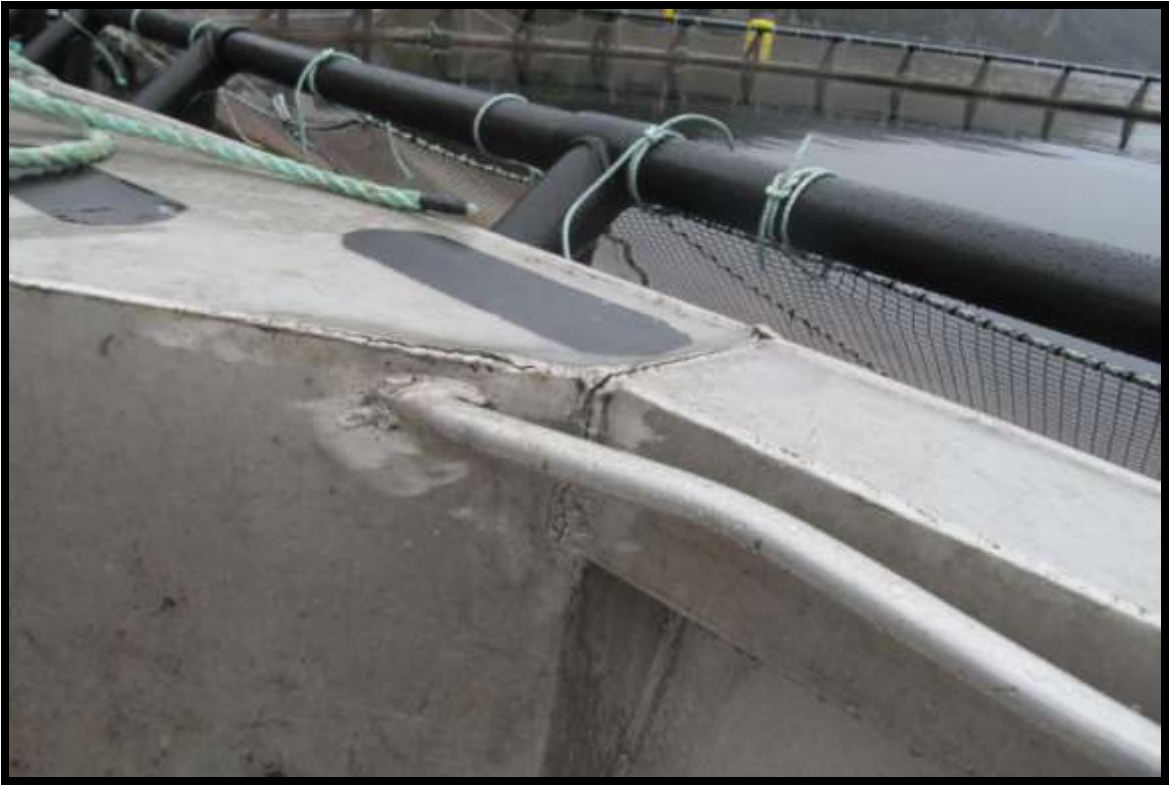
**BULWARK WELD FRACTURES**

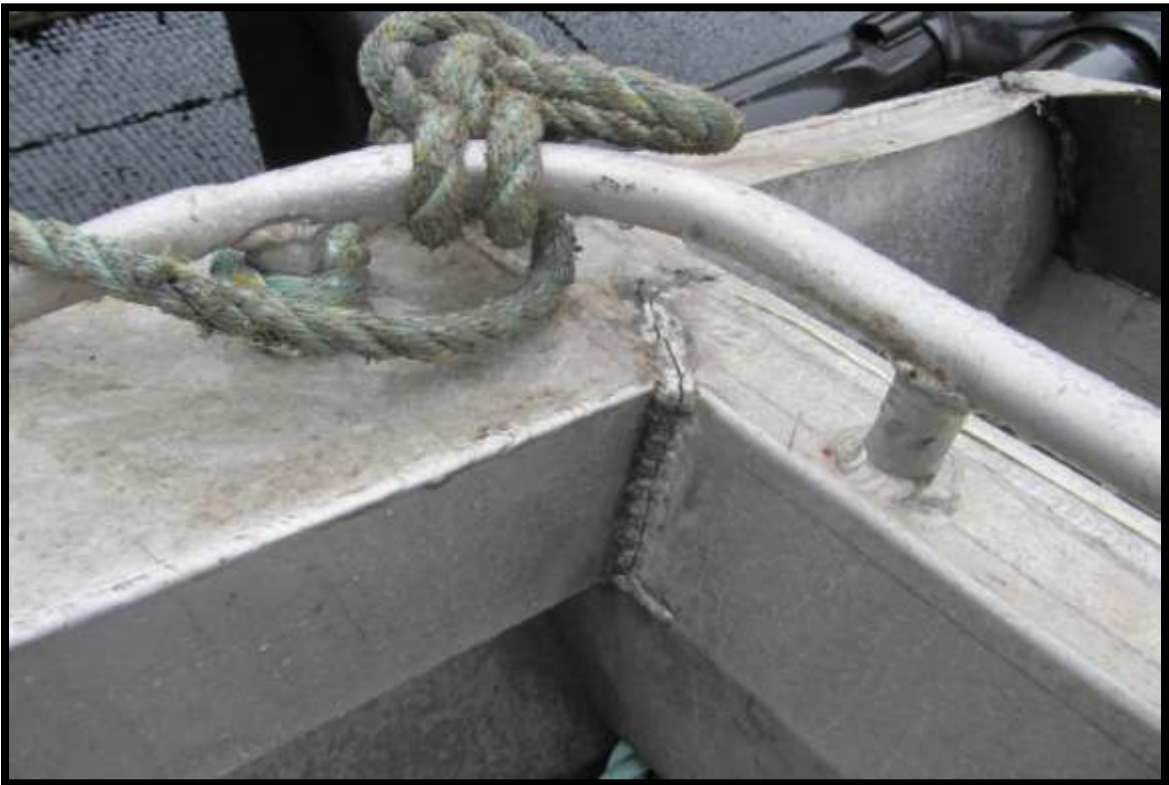
**BULWARK WELD FRACTURES**

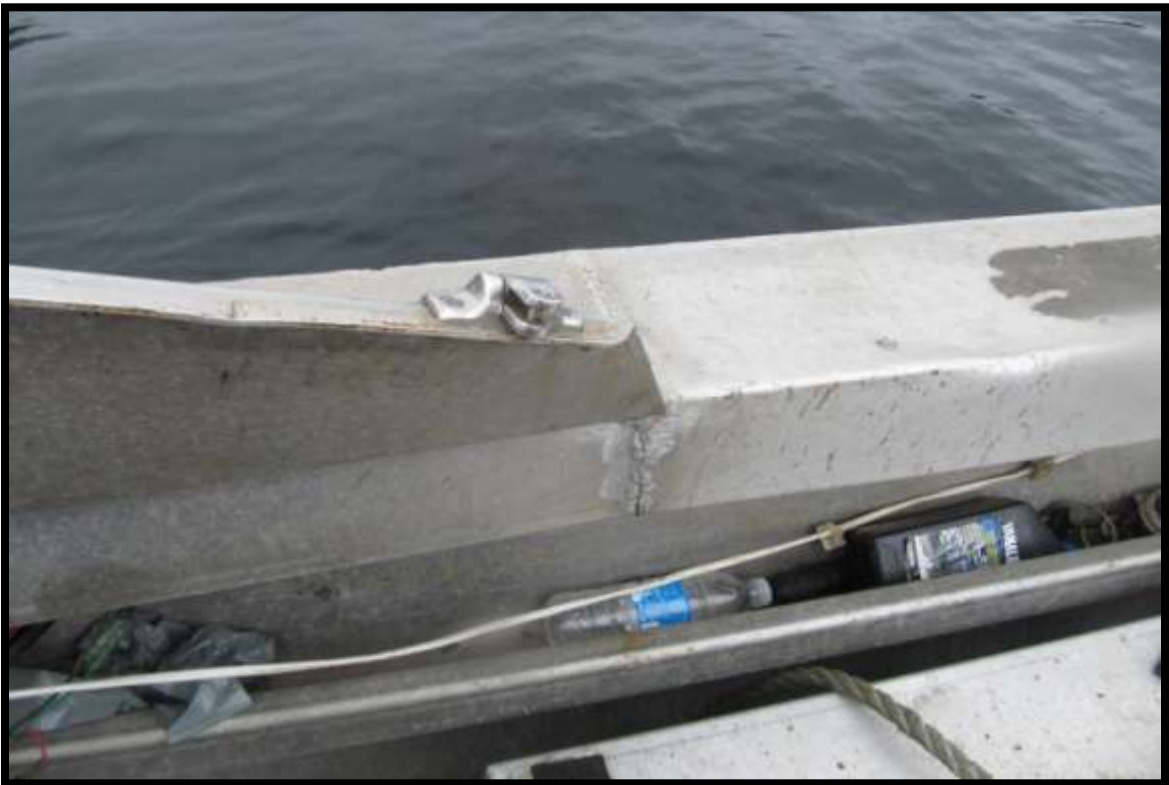
**BULWARK WELD FRACTURE**

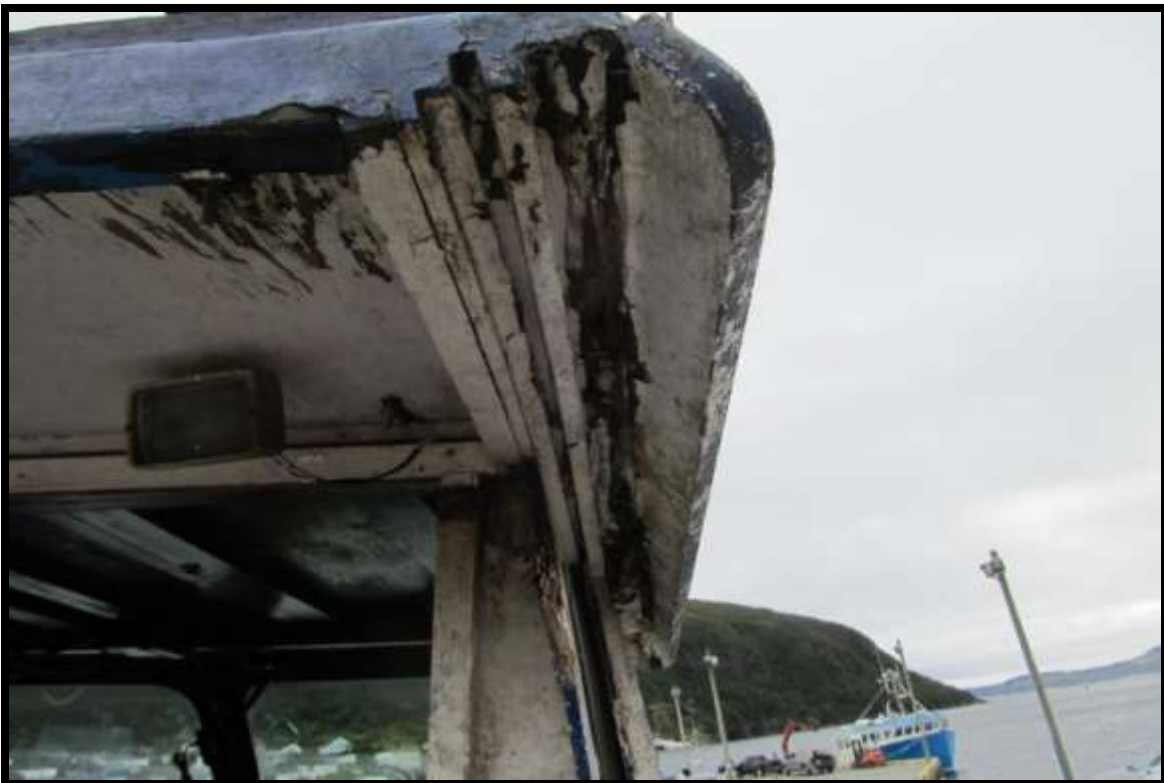
**STARBOARD SIDE EAVE AND DECK DAMAGE. EXTENSIVE ROT NOTED**

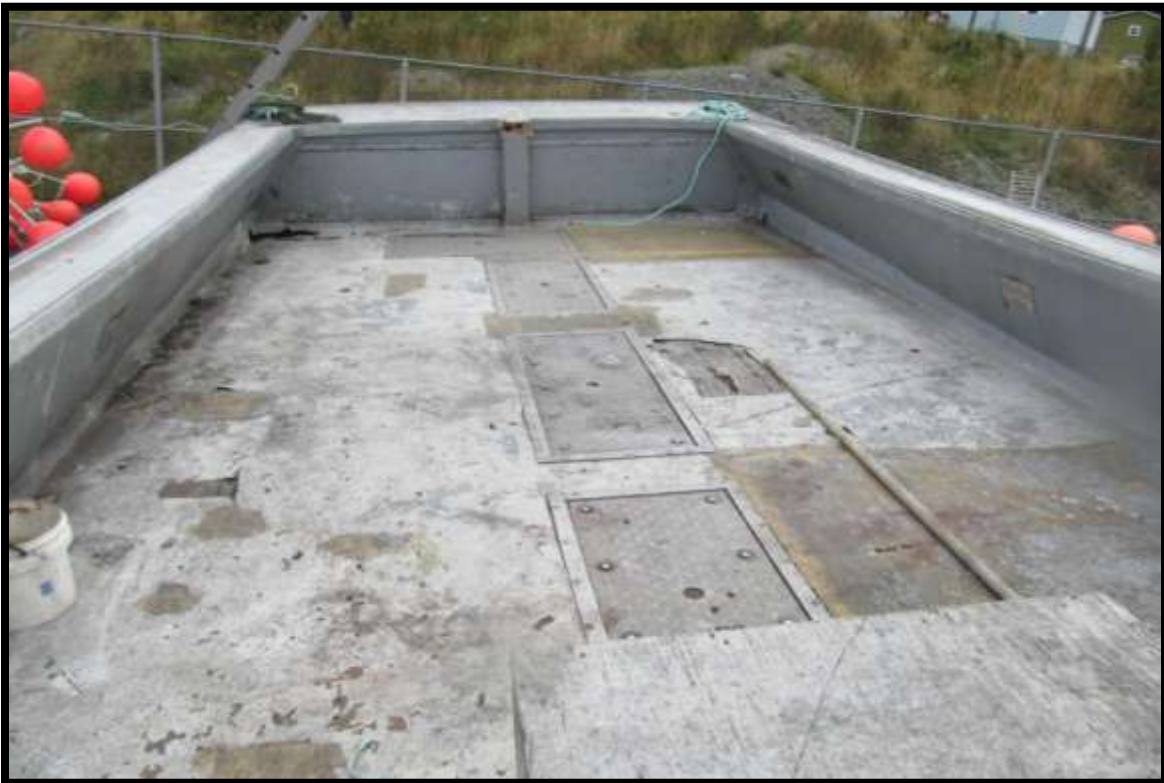
**MAIN DECK LOOKING AFT. EXTENSIVE DELAMINATION NOTED**
