**Finfish (Salmon & Trout)  
Aquaculture Processing Plant,  
Water Treatment & Feed Facilities,  
1-3 Plant Road & 37 Main Highway,  
Hermitage-Sandyville, NL**

**Effective Date: September 15, 2016**

**Re: Current Market Value & "Forced Liquidation" Value Appraisal,  
Finfish (Salmon & Trout) Aquaculture Processing Plant,  
Water Treatment & Feed Facilities,  
1-3 Plant Road & 37 Main Highway (Route 363), Hermitage-Sandyville, NL**

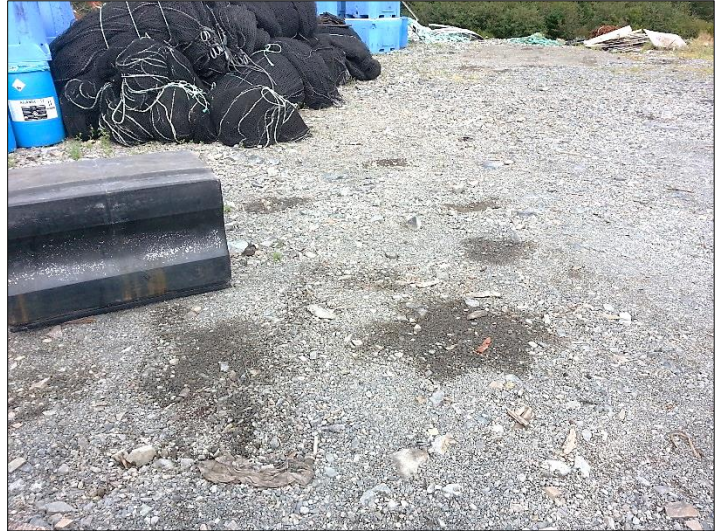
What appears to be surface petroleum product staining was observed in places on Site 3 (see image, right). An Environmental Site Assessment would verify the extent of any surface contamination.

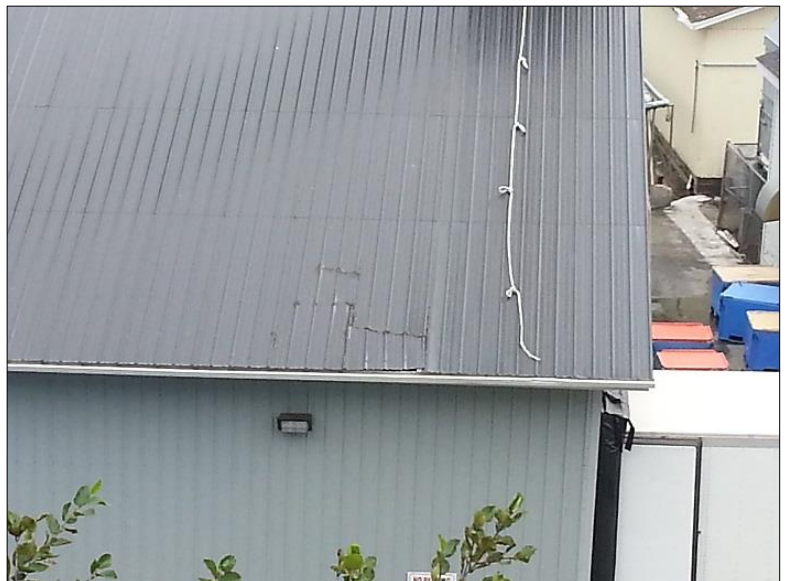
**5.5 General Condition & Utility**

The three structures are in very good overall condition, having been built in 2012. There is some minor damage to the processing plant's metal roof finish at the eave of the receiving bay (see image, right). A small portion of the metal flat stock eave trim is missing at the peak of the plant's northwestern gable end and along the water treatment facility's eave.

Functionally, the processing plant and the freestanding water treatment facility were purpose-built for finfish (salmon and trout) aquaculture processing. The site is narrow which limits truck access and the movement of product and materials on site.
