## **AQUACULTURE SUPPORT VESSEL APPRAISAL REPORT**

### **“SKIFF BARRETT”**

**REPORT #16128 - 1**

**DATE: September 2016**

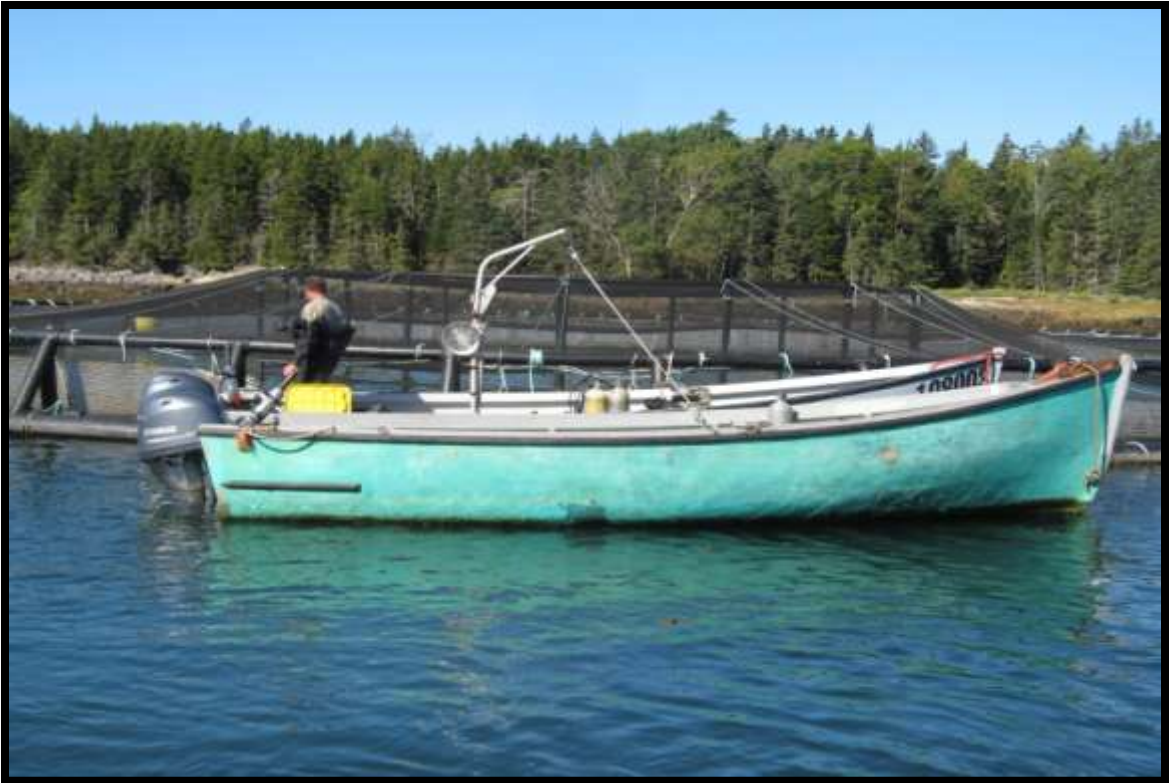
**STARBOARD SIDE VIEW**

The vessels hull (where visible) was found to have minor scrapes and gouges over the hull sides and transom area.

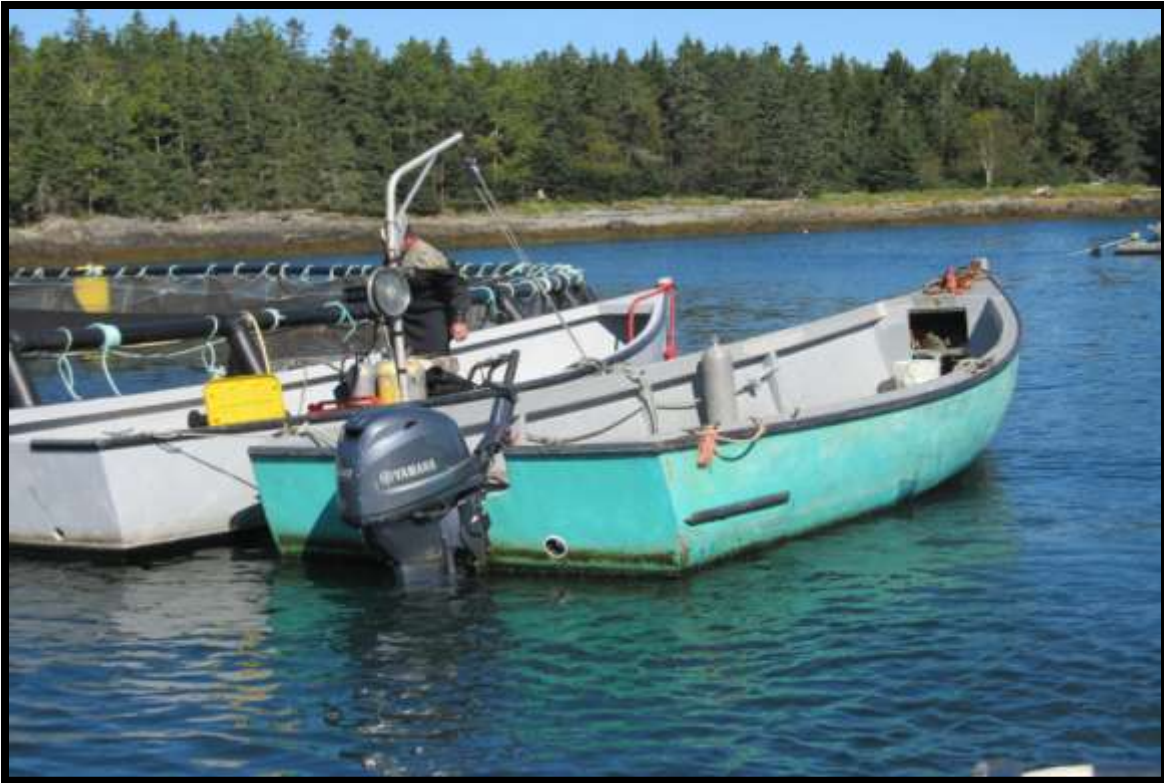
**STERN QUARTER VIEW**

| <u>ITEM</u> | <u>COMMENTS / CONDITION</u> |
|---|---|
| <b>REMARKS:</b> The vessel was in the water at the time of survey and all below water components were inaccessible; however all above water components was found to be in fair to average visual condition. Minor scrapes, gouges and scuffs noted over length of vessel. | |

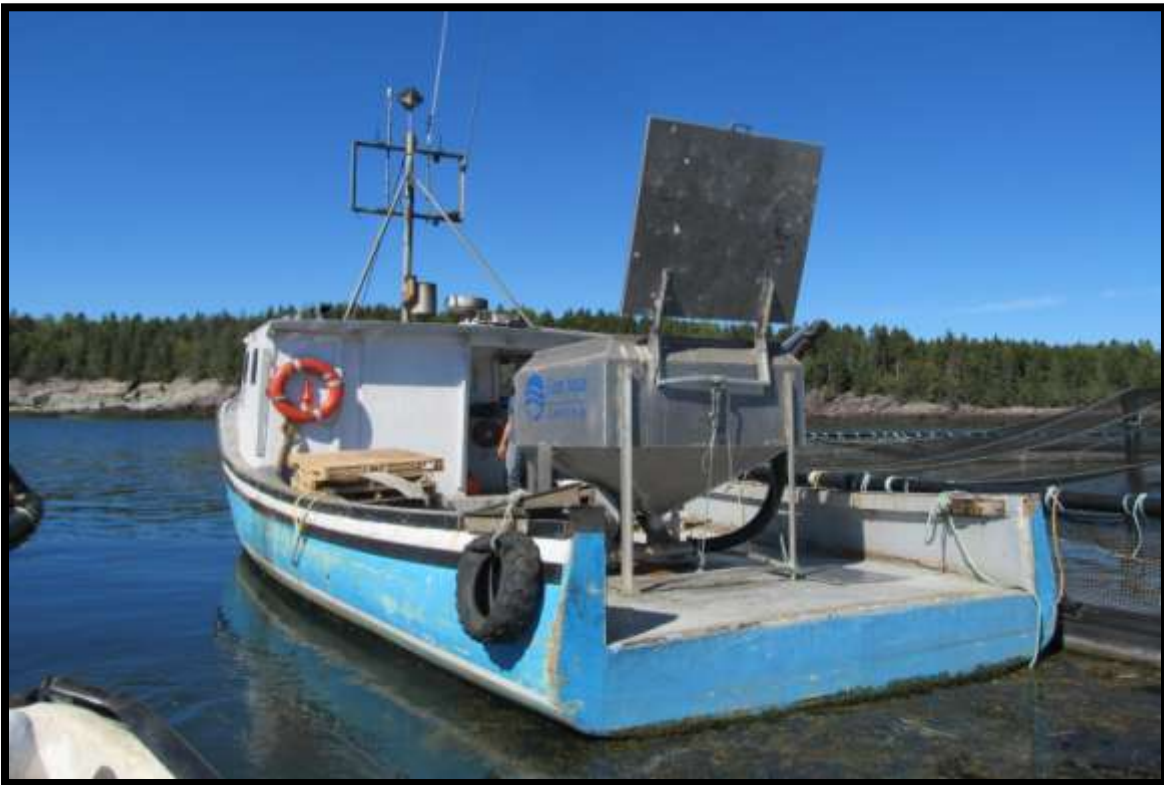
**STERN VIEW**

| <b>REMARKS:</b> The vessel was in the water at the time of the survey; all above water components were in fair to average visual condition. Scrapes and gouges noted over length of hull. Heavier damaged noted on the bulwarks at the deck connection and on the transom | |

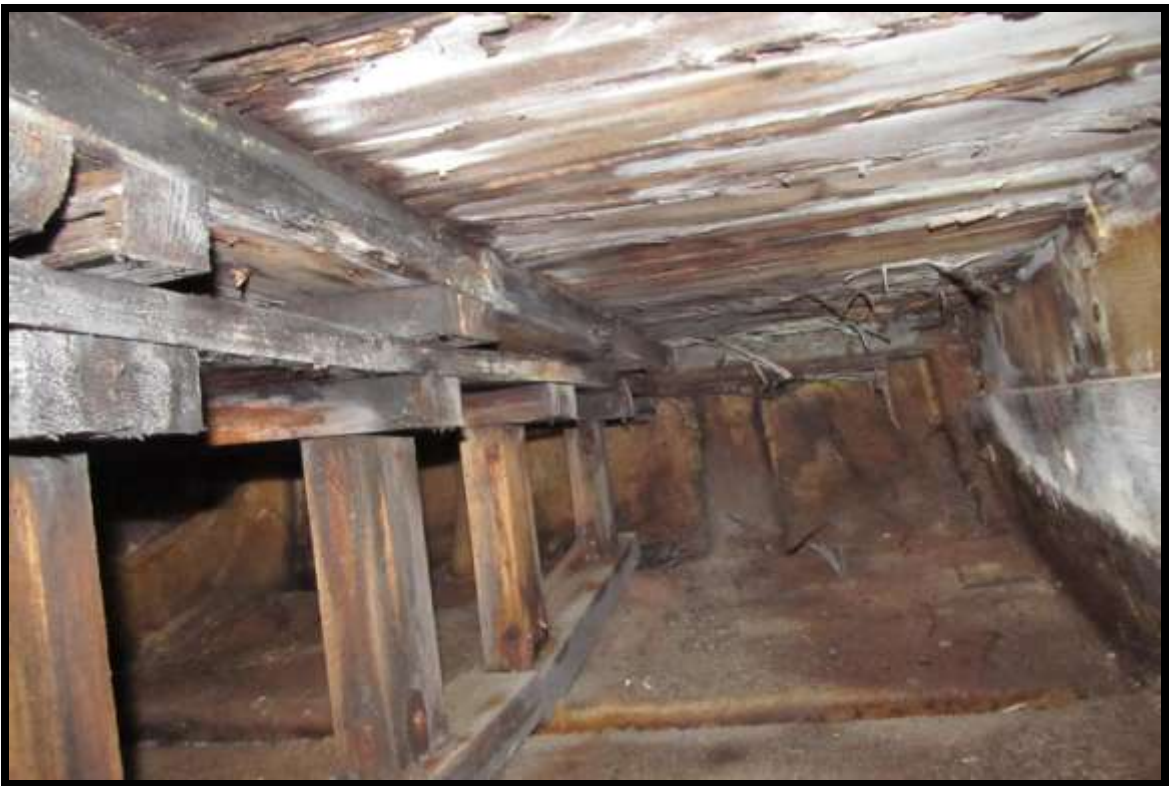
**MAIN DECK STRUCTURE**

| <b><u>ITEM</u></b> | <b><u>COMMENTS / CONDITION</u></b> |
|---|---|
| <b>REMARKS:</b> Vessels interior structure was found to be in fair condition where visible. Deterioration of deck beams in engine room and rot noted on the main deck wooden sheathing. | |

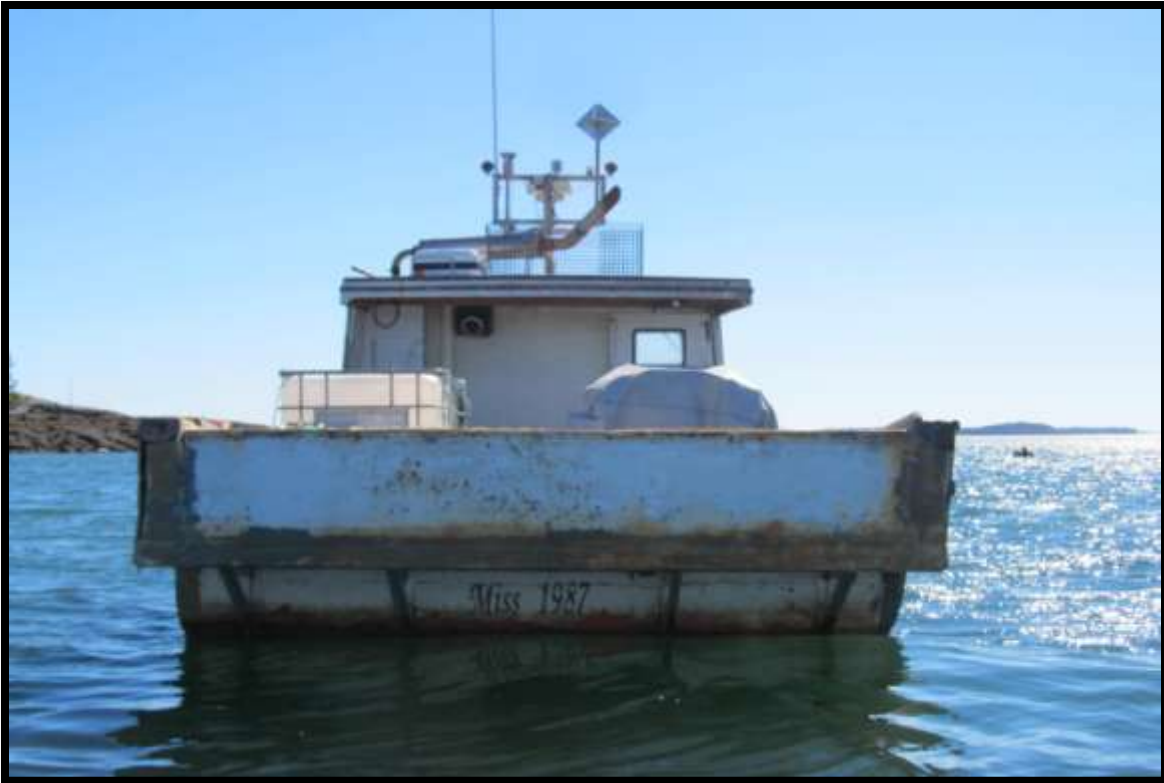
**STERN VIEW**

| <b>REMARKS:</b> The vessel was in the water at the time of the survey; all above water components were in fair to average visual condition. Scrapes and gouges noted over length of hull. Heavier damage noted on the transom. | |

Since the vessel was afloat at the time of the survey, the exterior underwater hull was inaccessible. The exterior hull, decks, deckhouse/wheelhouse were all found to be in fair to average visual condition. Scrapes and gouges were noted over length of hull. Heavier damage noted on the on the transom. Main deck structure was found to be in average visual condition.

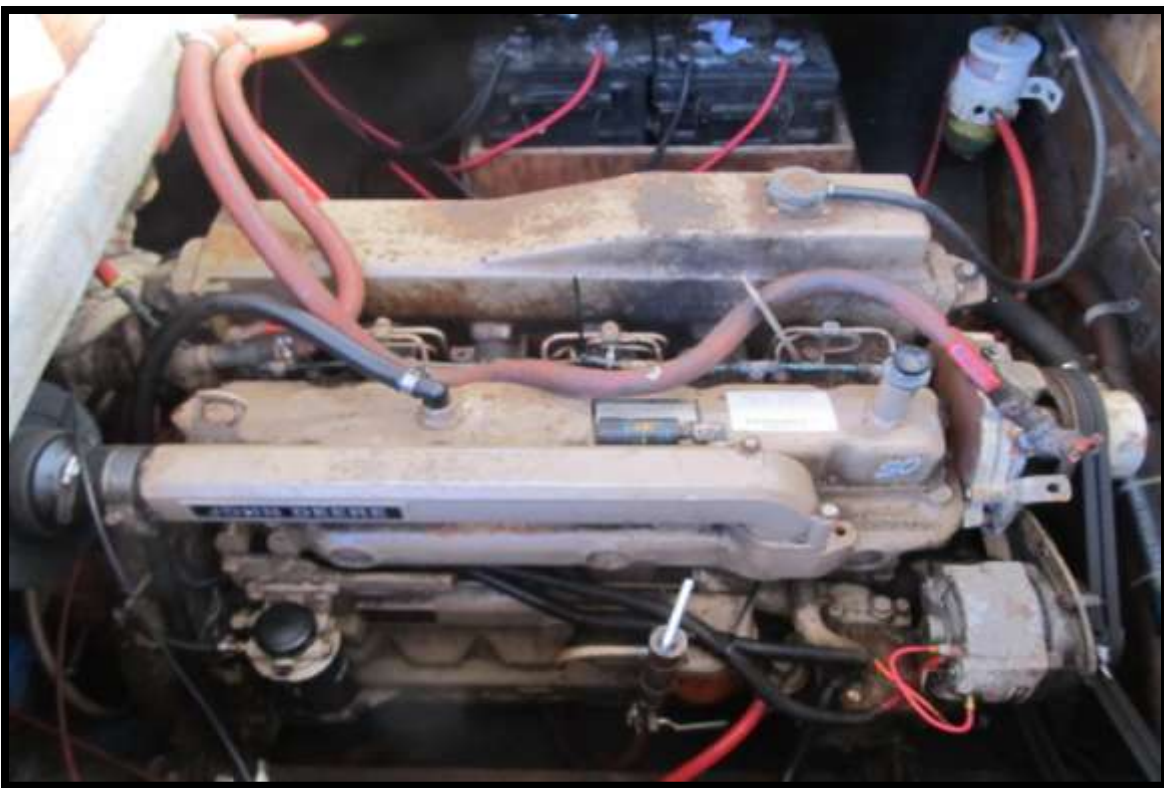
**MAIN ENGINE**

| <b>REMARKS:</b> Main engine appears to be in average visual condition. | |

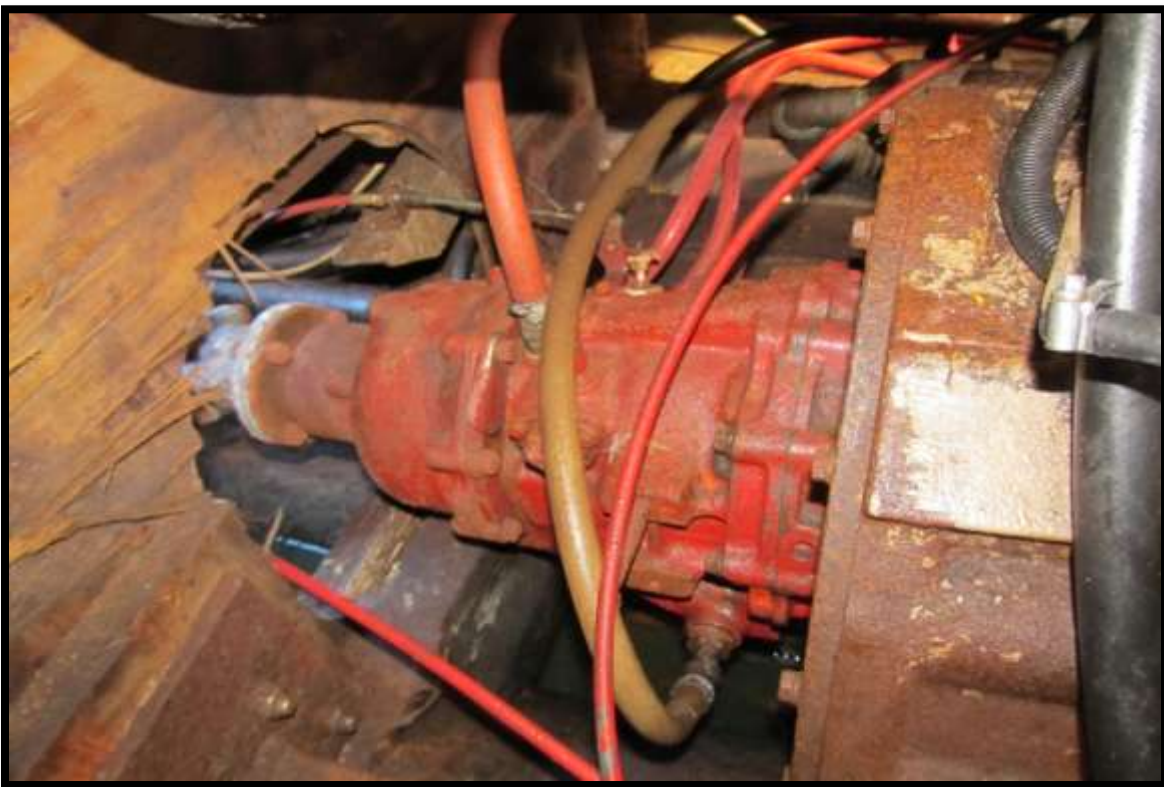
**TRANSMISSION**

| <b>REMARKS:</b> Transmission appears to be in average visual condition. | |

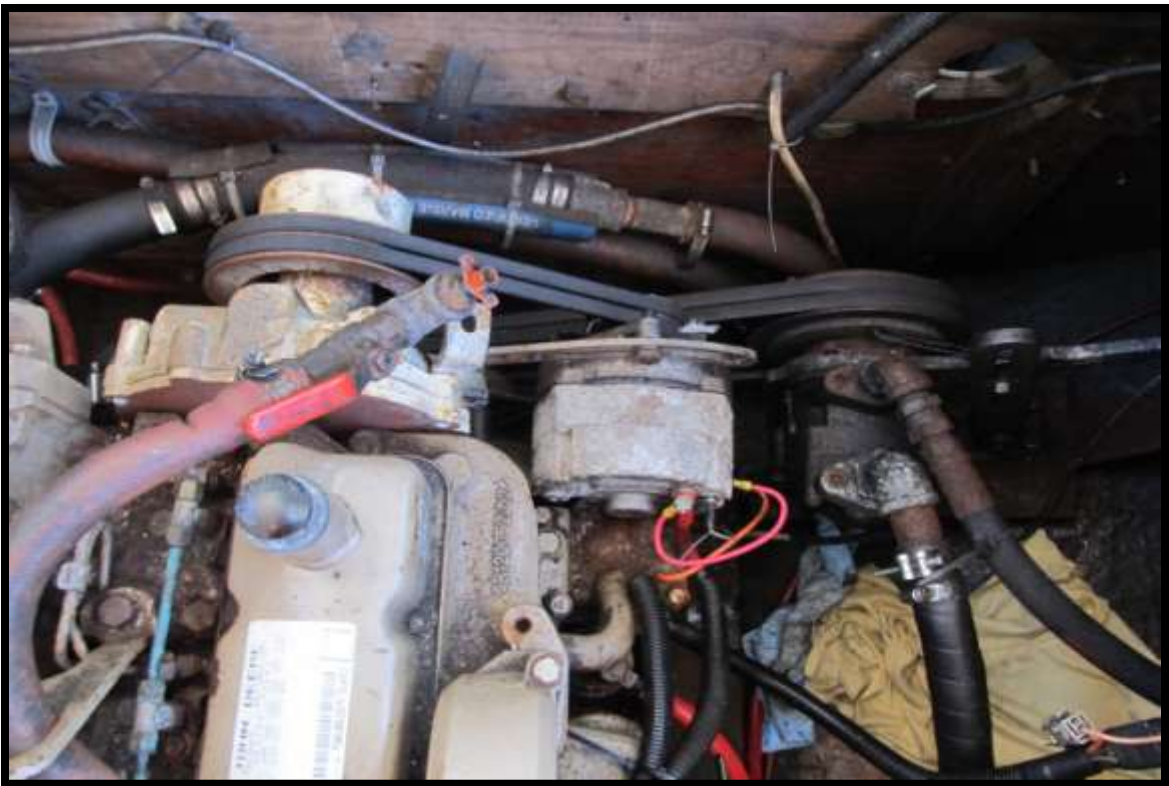
**ENGINE FRONT: HYDRAULICS AND ALTERNATOR**

| <b><u>ITEM</u></b> | <b><u>DESCRIPTION</u></b> | <b><u>CONDITION</u></b> |
|---|---|---|
| REMARKS: Hydraulic system appeared to be in average visual condition. | | |

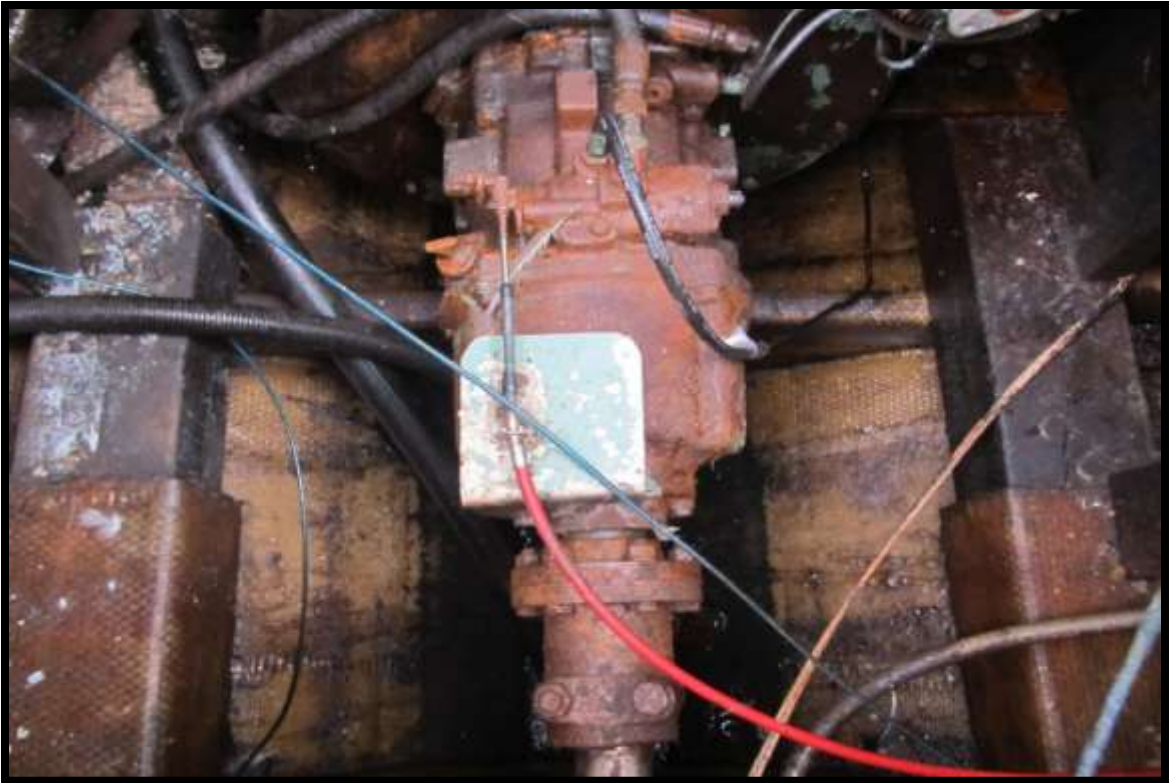
**MAIN ENGINE – HYDRAULICS NOT CONNECTED**

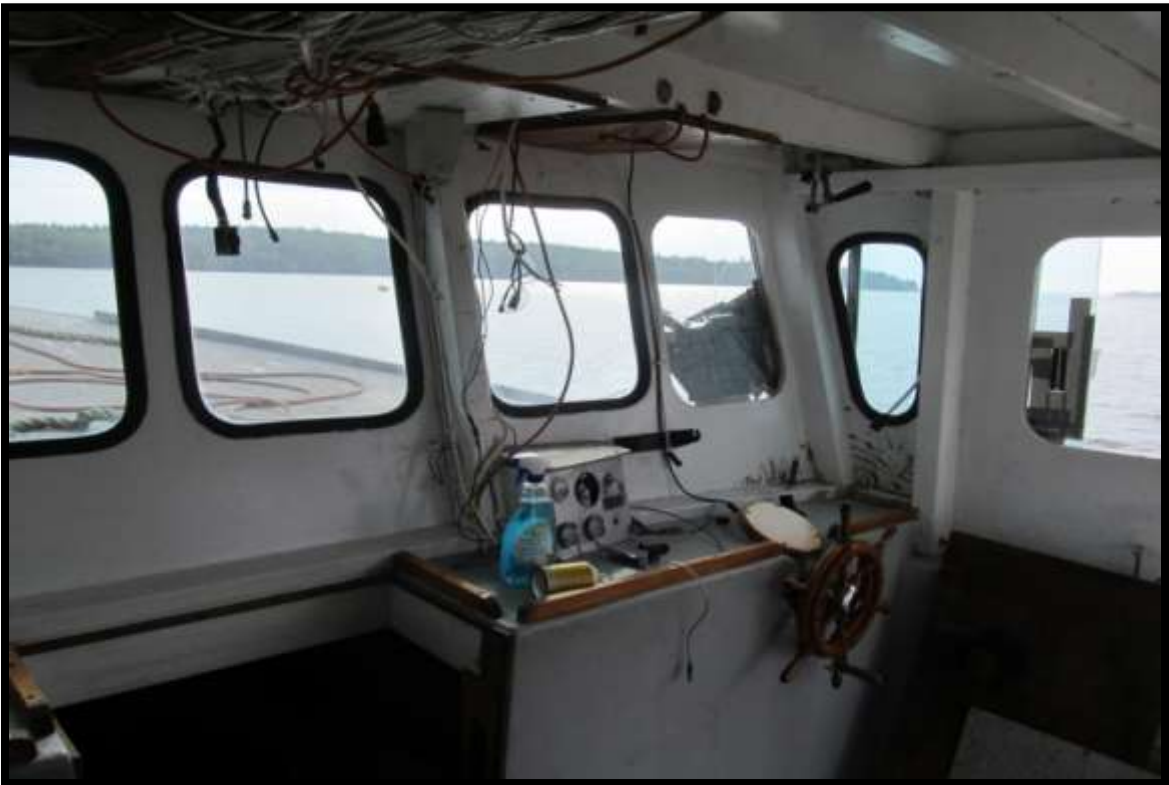
**WHEELHOUSE LOOKING STARBOARD**

Since the vessel was afloat at the time of the survey, the exterior underwater hull was inaccessible. The exterior hull, decks, deckhouse/wheelhouse were all found to be in fair to average visual condition. Scrapes and gouges were noted over length of hull. Main deck structure was found to be in average visual condition while the wheelhouse structure showed signs of deterioration and rot.

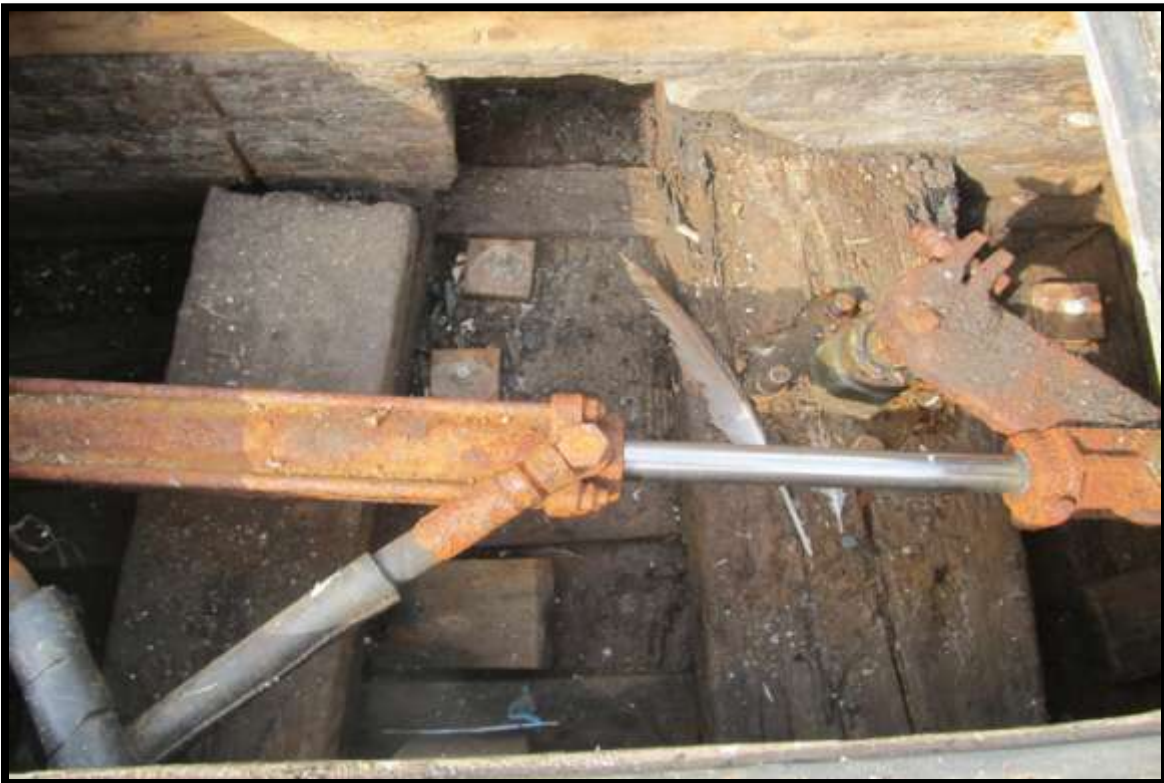
| <b><u>ITEM</u></b> | <b><u>COMMENTS / CONDITION</u></b> |
|---|---|
| <b>REMARKS:</b> Vessel structure was found to be in fair to average visual condition. Some deterioration and rot noted on hull frames and within aft vessel structure in way of steering gear. | |

**STEERING GEAR**

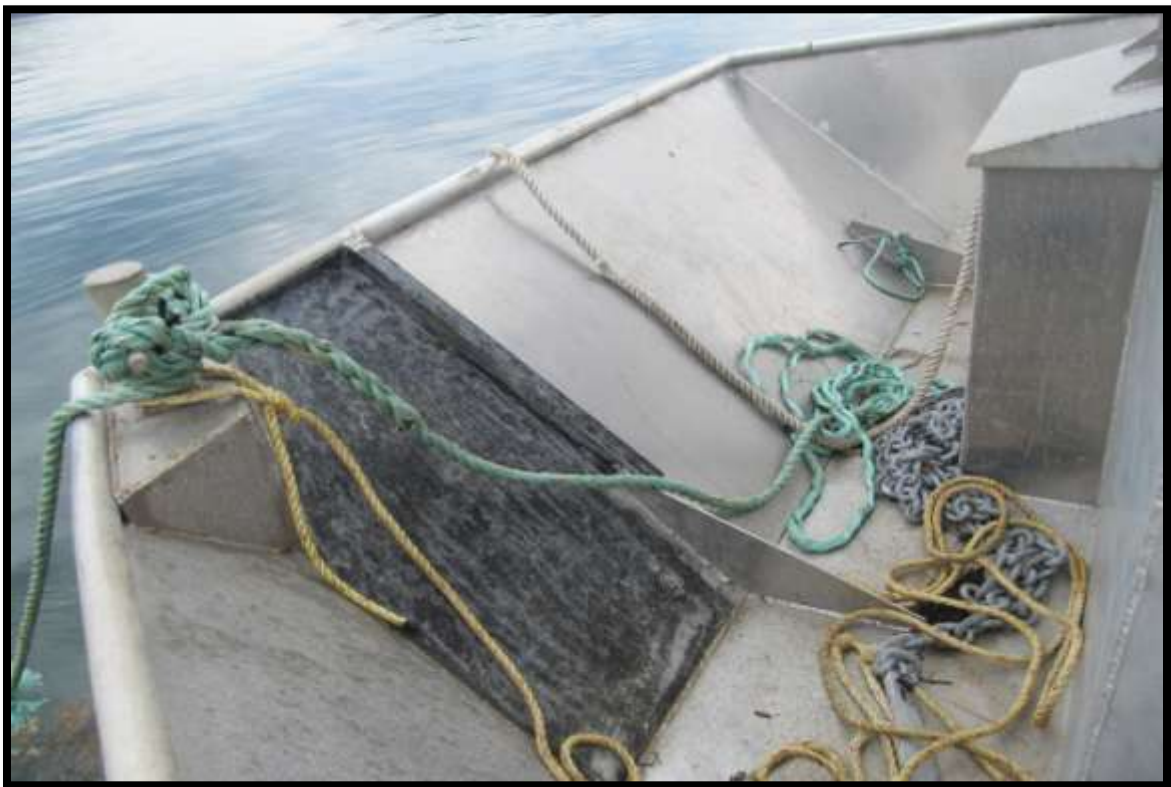
| <b>REMARKS:</b> The vessel was in the water at the time of survey; all above water components were found to be in average visual condition. Several large dents were noted on the starboard side bow area. | |

**WHEELHOUSE TOP**

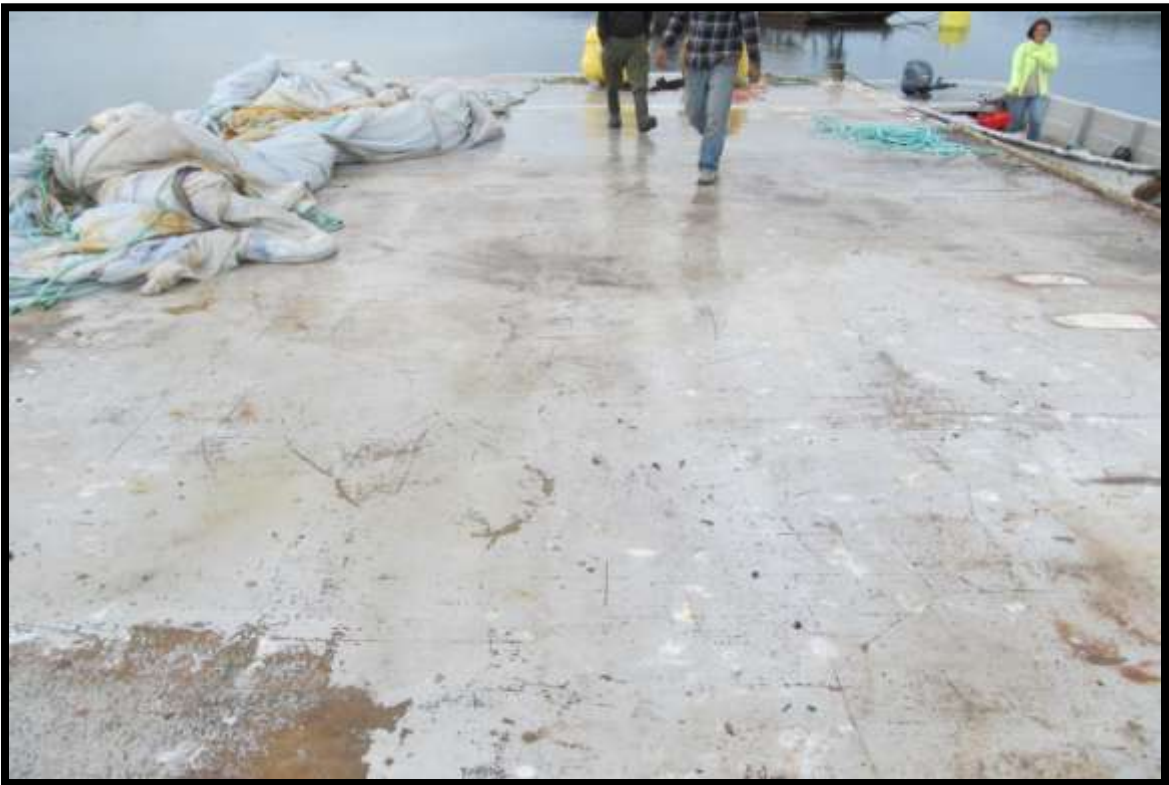
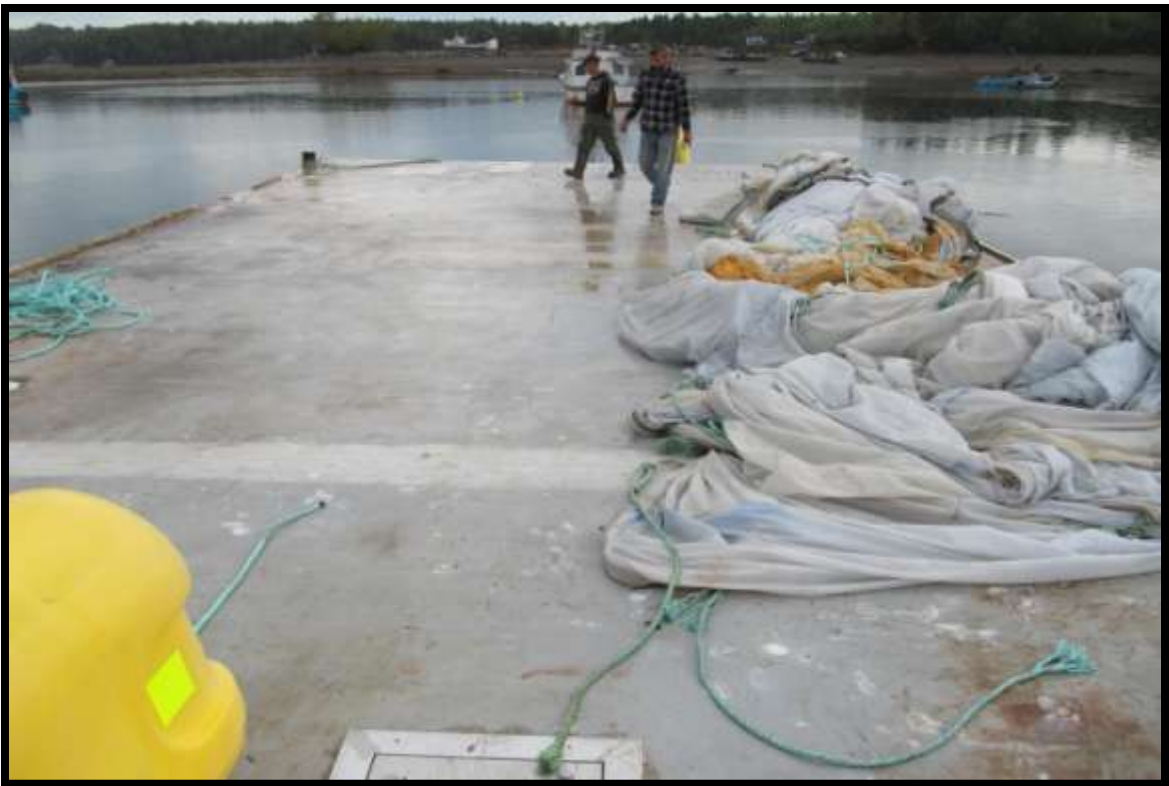
| <b>REMARKS:</b> Barge was found to be in fair visual condition. Scrapes and gouges noted over barge sides. Cracks and fiberglass delamination noted over the main deck. | |

Fiberglass delamination noted on main deck and damage noted around perimeter of deck edges.

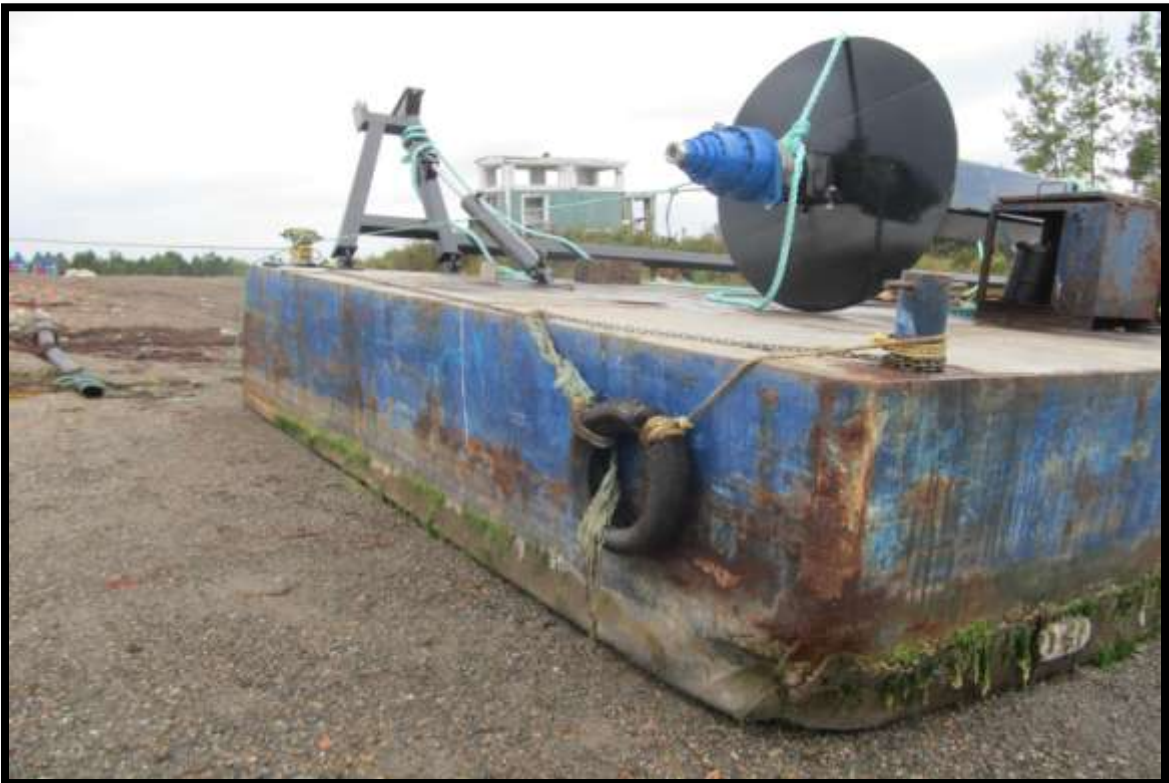
| <u>ITEM</u> | <u>COMMENTS / CONDITION</u> |
|---|---|
| STERN | Steel, indentations throughout and damage noted on aft starboard corner / average |

| <b>REMARKS:</b> The barge was beached at the time of the survey; bottom plating was inaccessible. Hull sides, bow, stern and deck) were found to be in a generally average visual condition. No major damage noted, however a large indentation noted on the starboard aft lower corner of the transom. | |

**TRANSOM – DAMAGE NOTED ON STARBOARD BOTTOM CORNER**

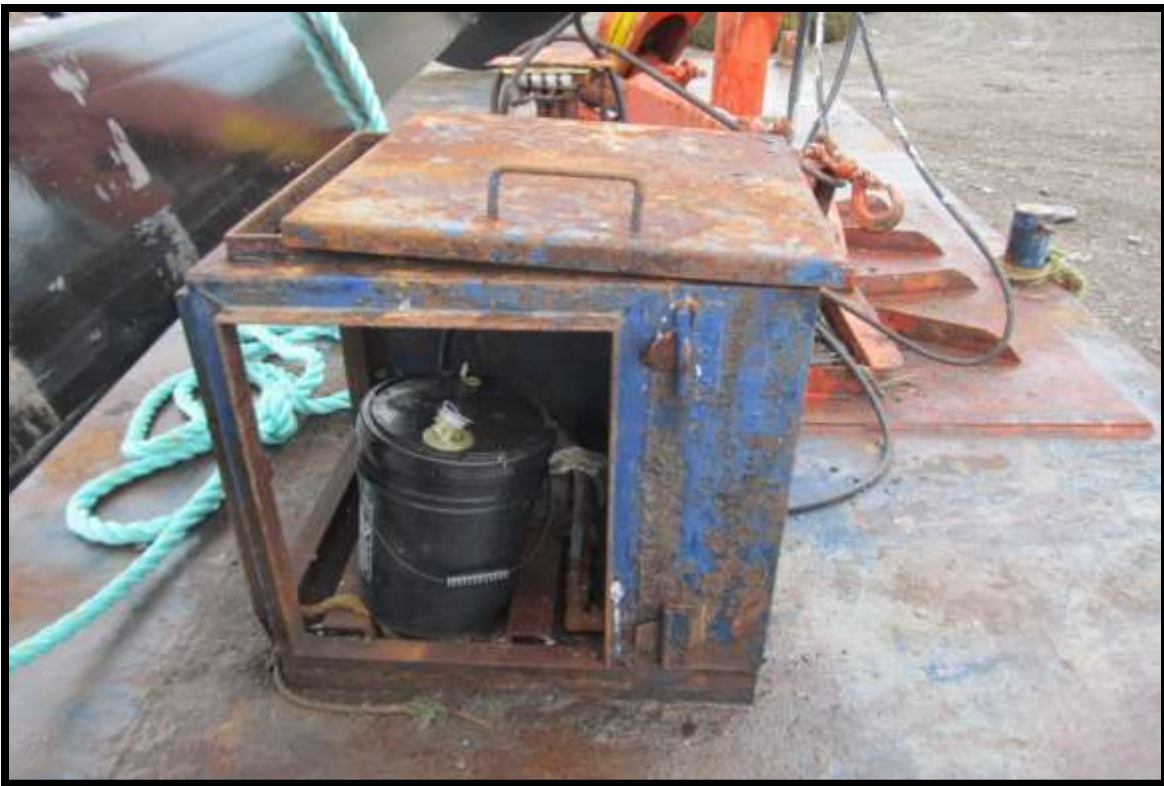
**ENCLOSURE FOR HPU – NOT INSTALLED**

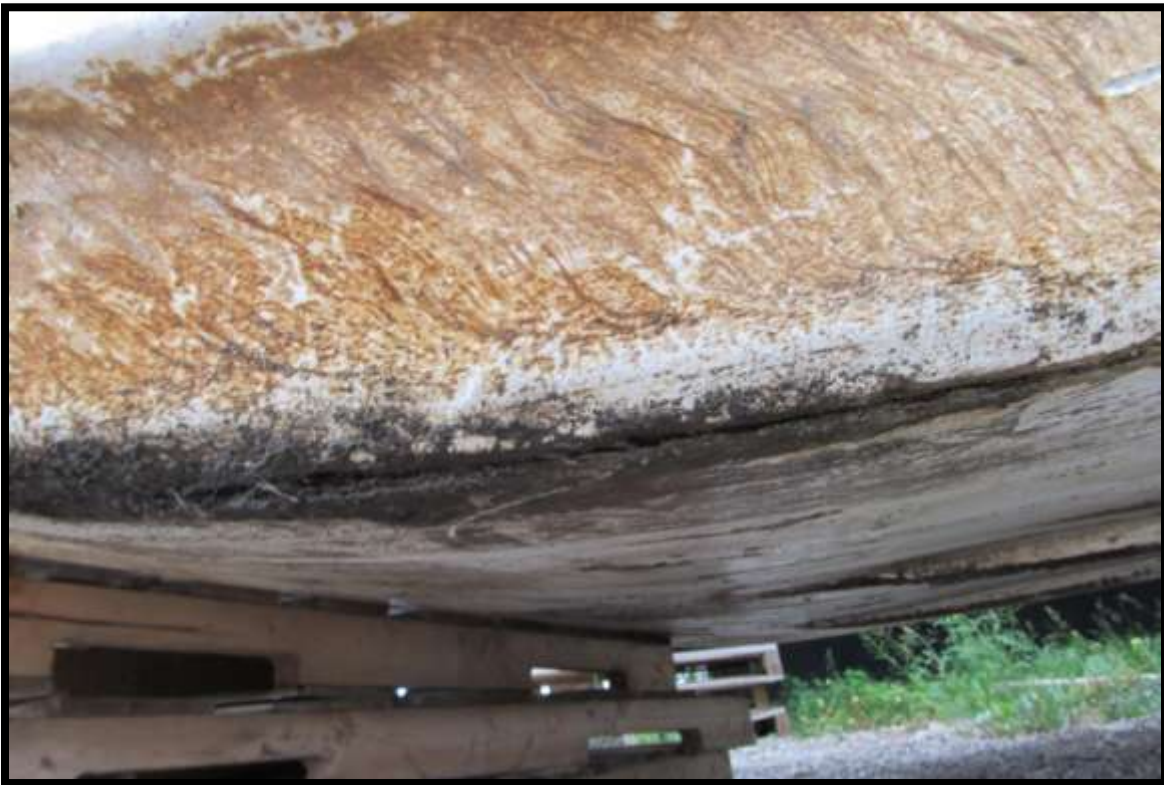
**UNDERWATER HULL DAMAGE**

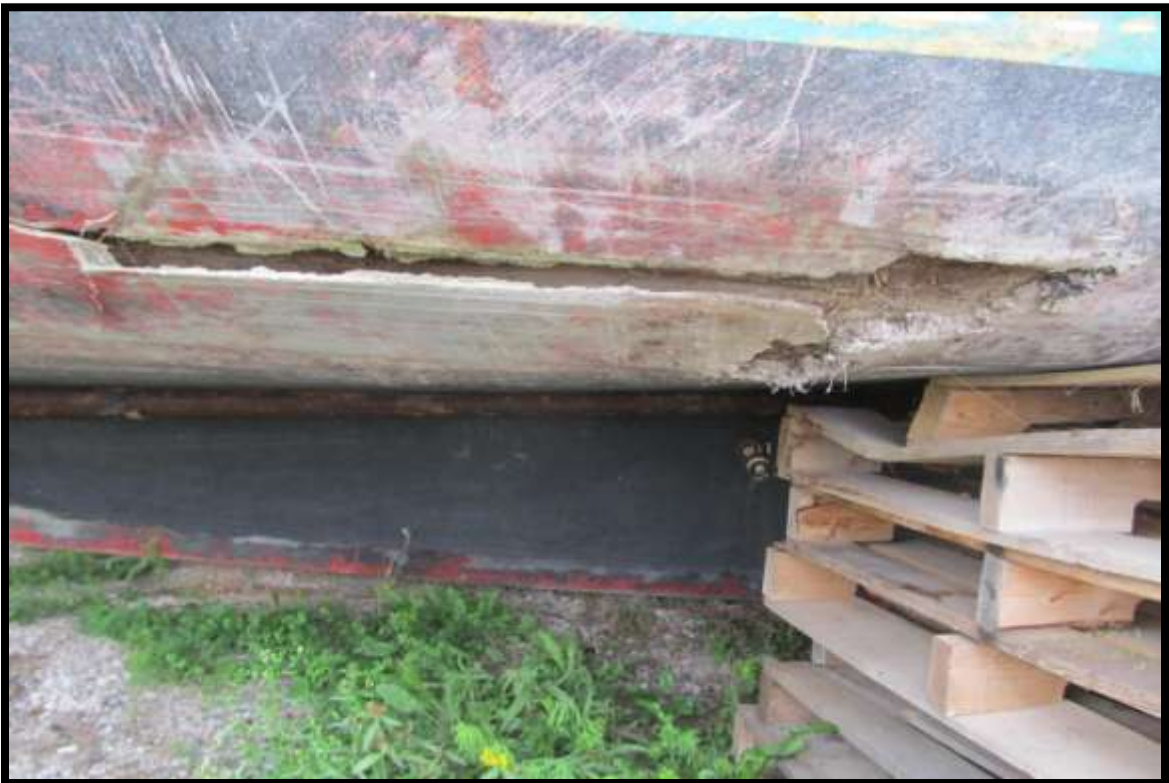
Extensive underwater hull damage consisting of holes located on the hull bottom on the forward, aft, port and starboard sides.; Multiple scrapes and gouges were noted on the hull sides and extensive fiberglass damage exposing hull wooden structure on the port and starboard hull sides adjacent the transom. Deck and deck house/wheelhouse were found to be in fair to average visual condition, however fore'sle deck damage evident. Main deck and hull side frame structure was found to be in an overall fair visual condition. Hull bottom frames were found to be in poor visual condition; wood deterioration, rot and damage was evident.

**PORT SIDE HULL DAMAGE**

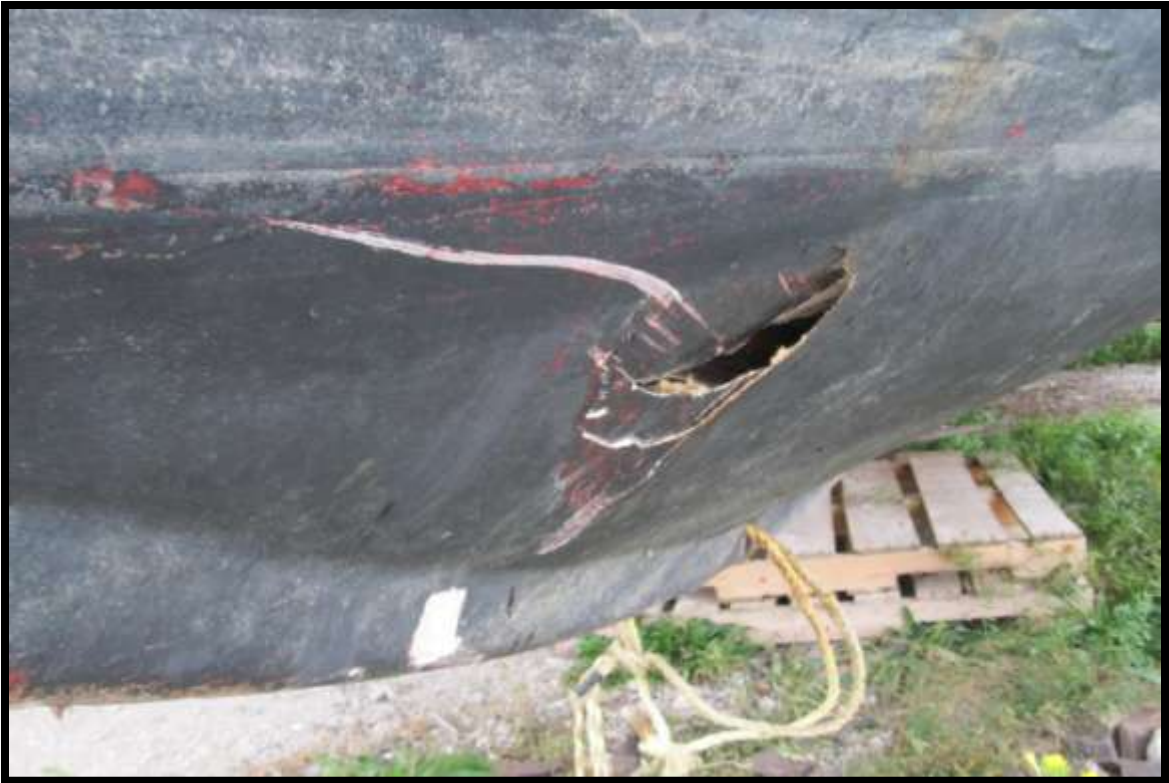
**BOW DAMAGE**

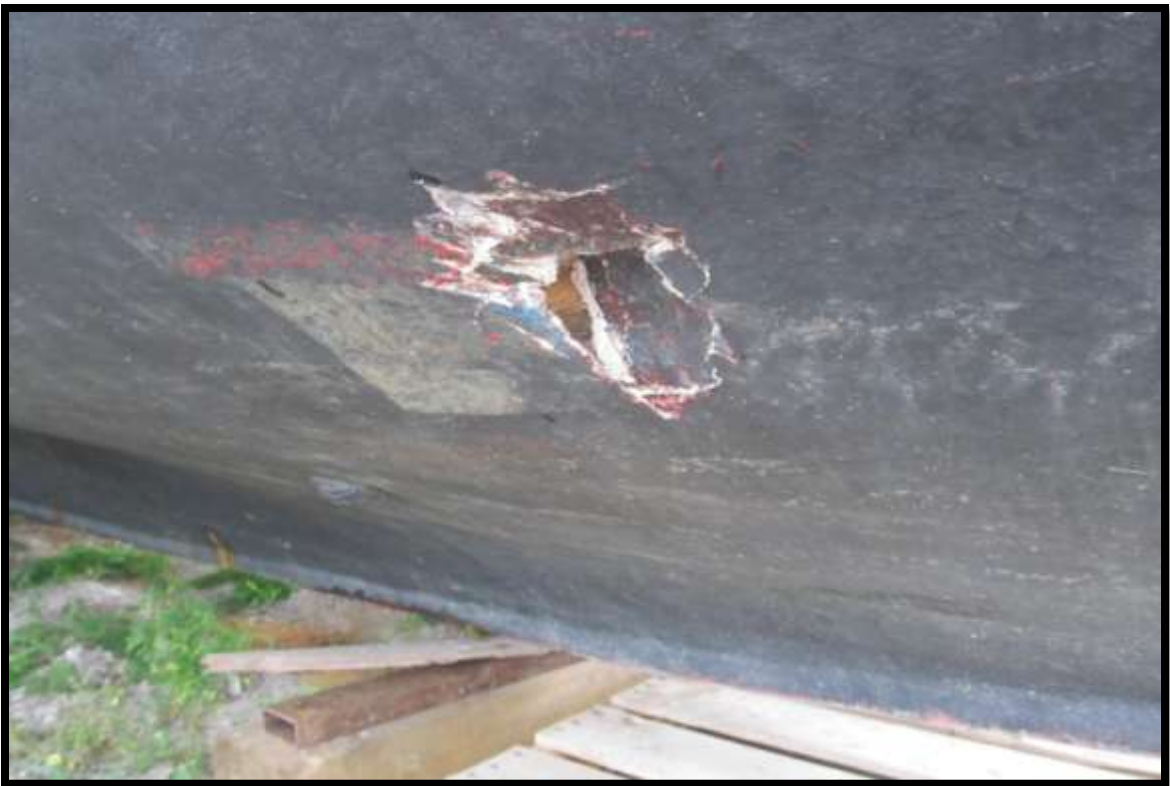
**STARBOARD SIDE HULL DAMAGE**

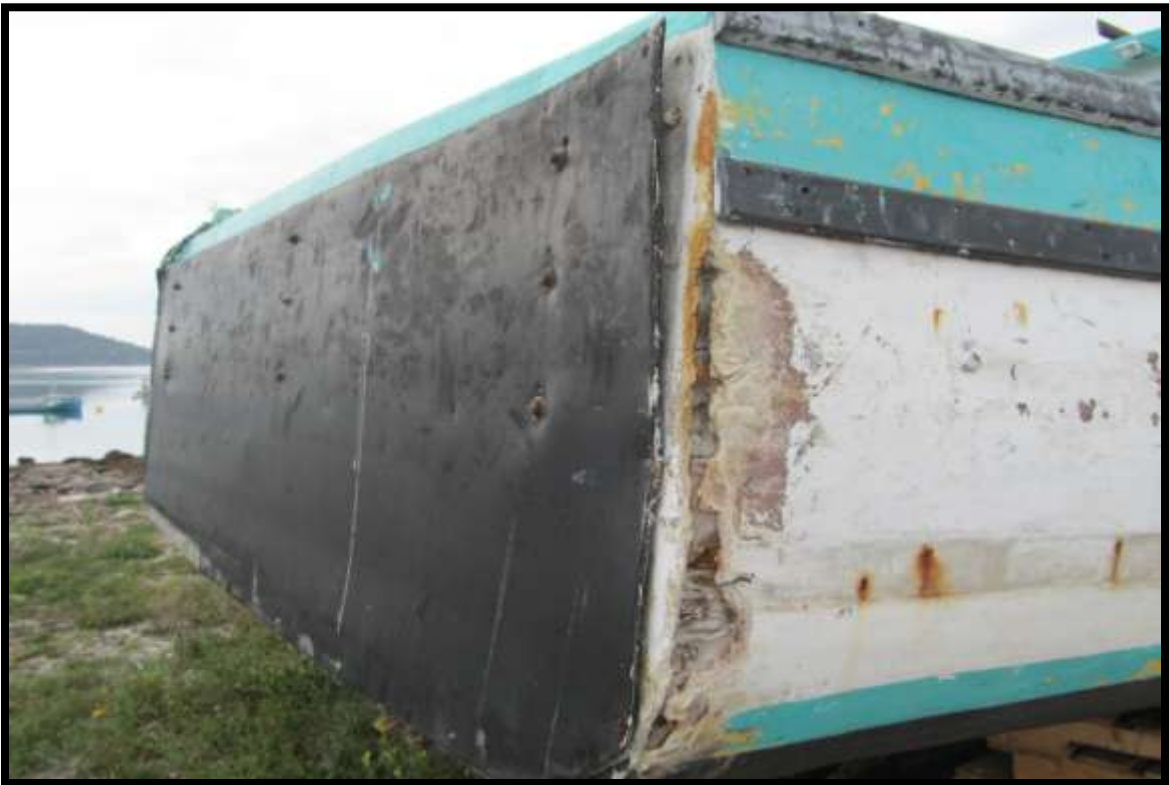
**STARBOARD SIDE AFT HULL/TRANSOM DAMAGE**

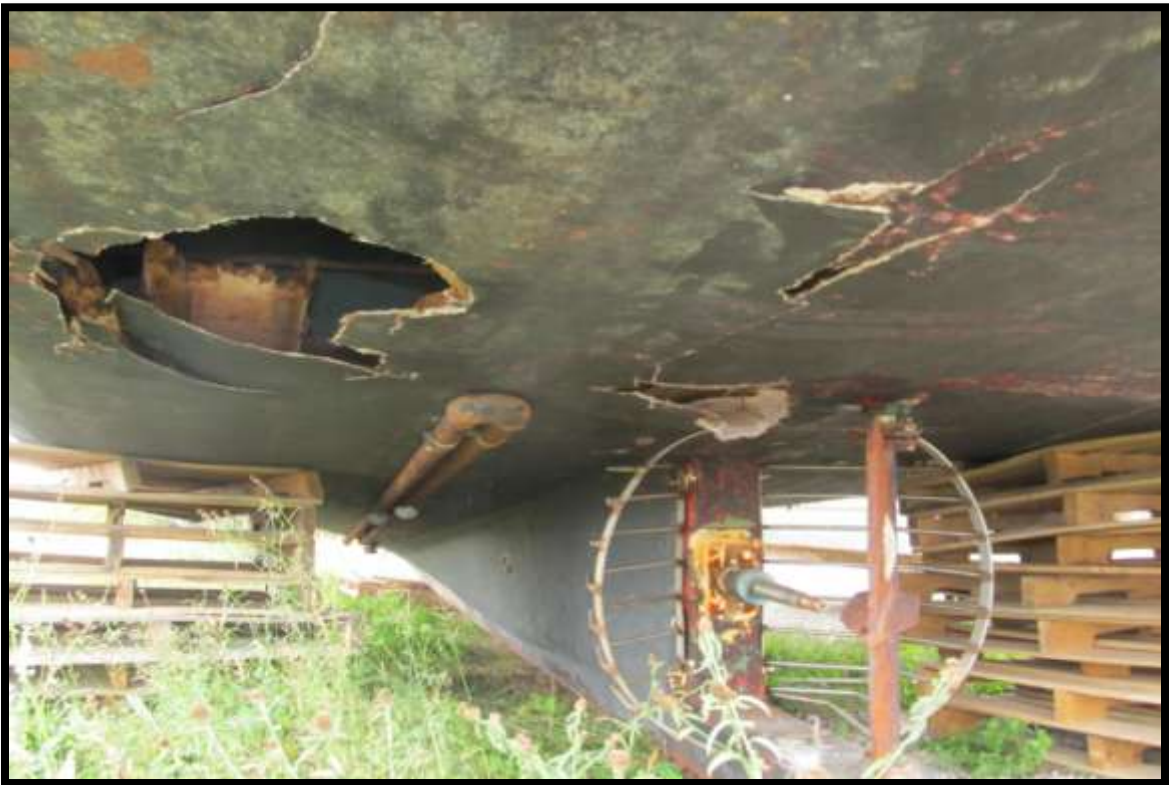
**AFT UNDERWATER HULL DAMAGE**

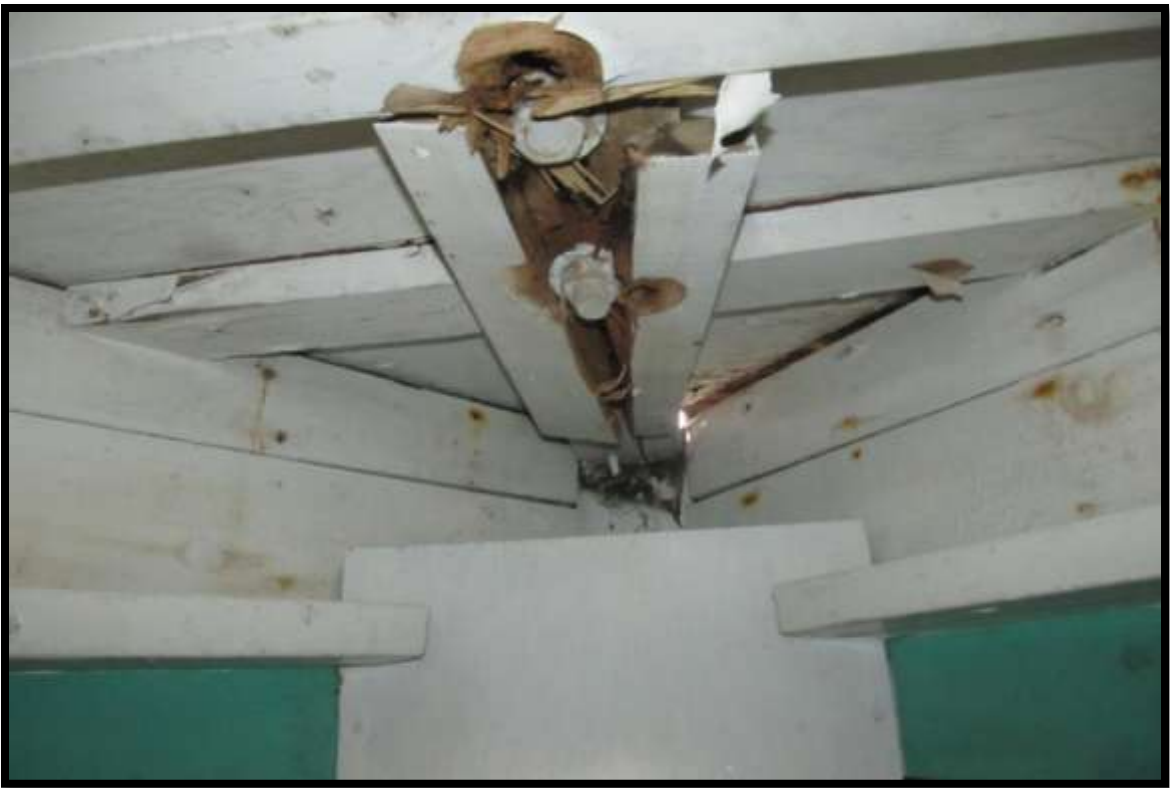
| <b>REMARKS:</b> The vessel was out of the water at the time of survey. Hull was found to be in poor visual condition and not seaworthy nor watertight in its current condition. Extensive underwater hull damage consisting of holes located on the hull bottom on the forward, aft, port and starboard sides. Multiple scrapes and gouges were noted on the hull sides and extensive fiberglass damage exposing wooden hull structure on the port and starboard hull sides adjacent the transom. Deck and deck house/wheelhouse were found to be in fair to average visual condition, however foc'sle deck damage evident. . | |

**FOC'SLE DECK STRUCTURE DAMAGE**
