## **AQUACULTURE SUPPORT VESSEL APPRAISAL REPORT**

### **“SKIFF BARRETT”**

**REPORT #16128 - 1**

**DATE: September 2016**

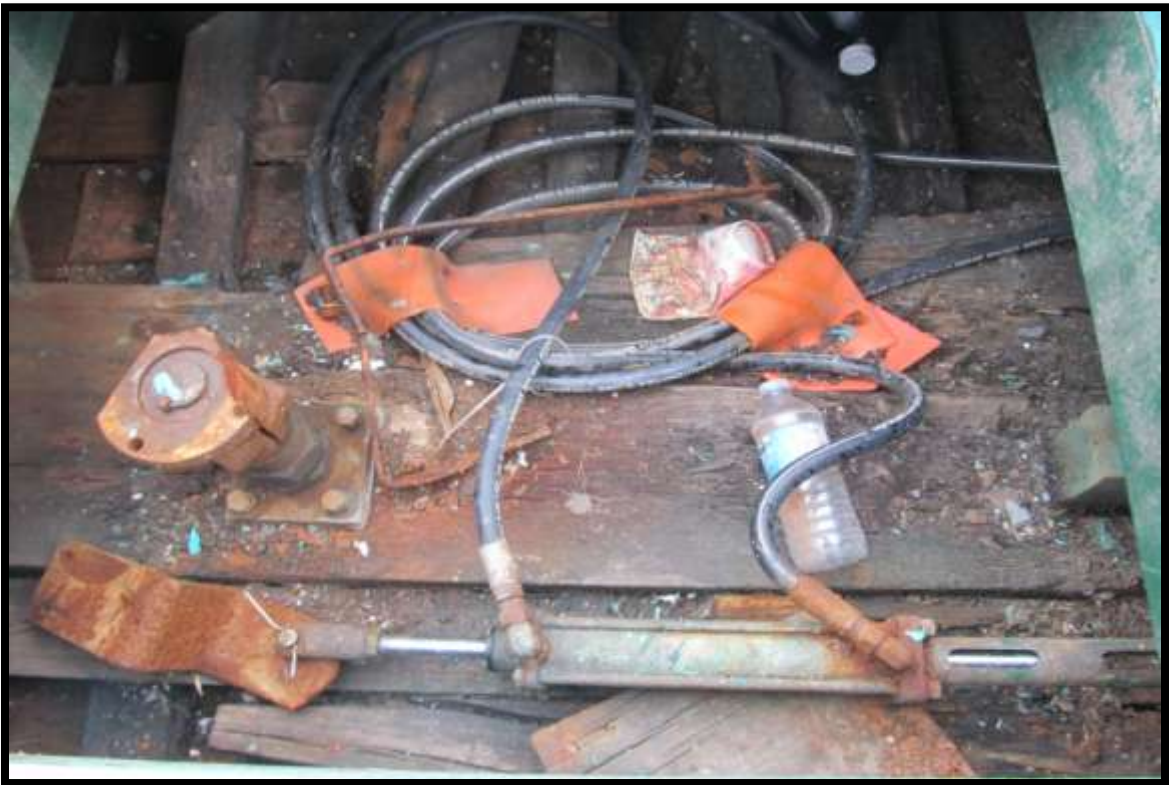
| <b><u>ITEM</u></b> | <b><u>DESCRIPTION</u></b> | <b><u>CONDITION</u></b> |
|---|---|---|
| STEERING TYPE / # OF STATIONS | Hydraulic single ram, not connected and damaged | Poor |

**STEERING GEAR**
