# AQUACULTURE SUPPORT VESSEL APPRAISAL REPORT

**“K.C.”**

**COMPLETED BY: TRINAV MARINE DESIGN  
ST. JOHN'S, NL**

**REPORT # 16128 - 18**

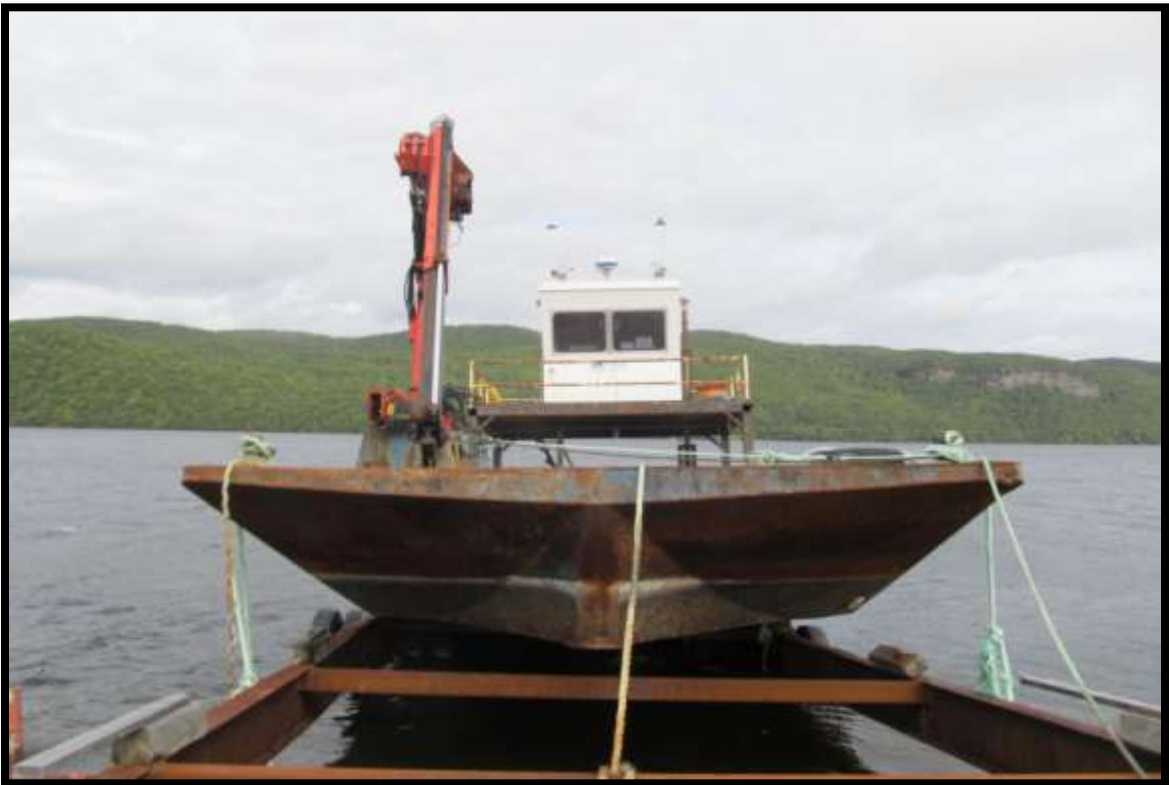
**BOW VIEW**

bottom (where visible) was noted to be in average visual condition. Minor dents and scrapes noted on the hull sides, bow area and deck.

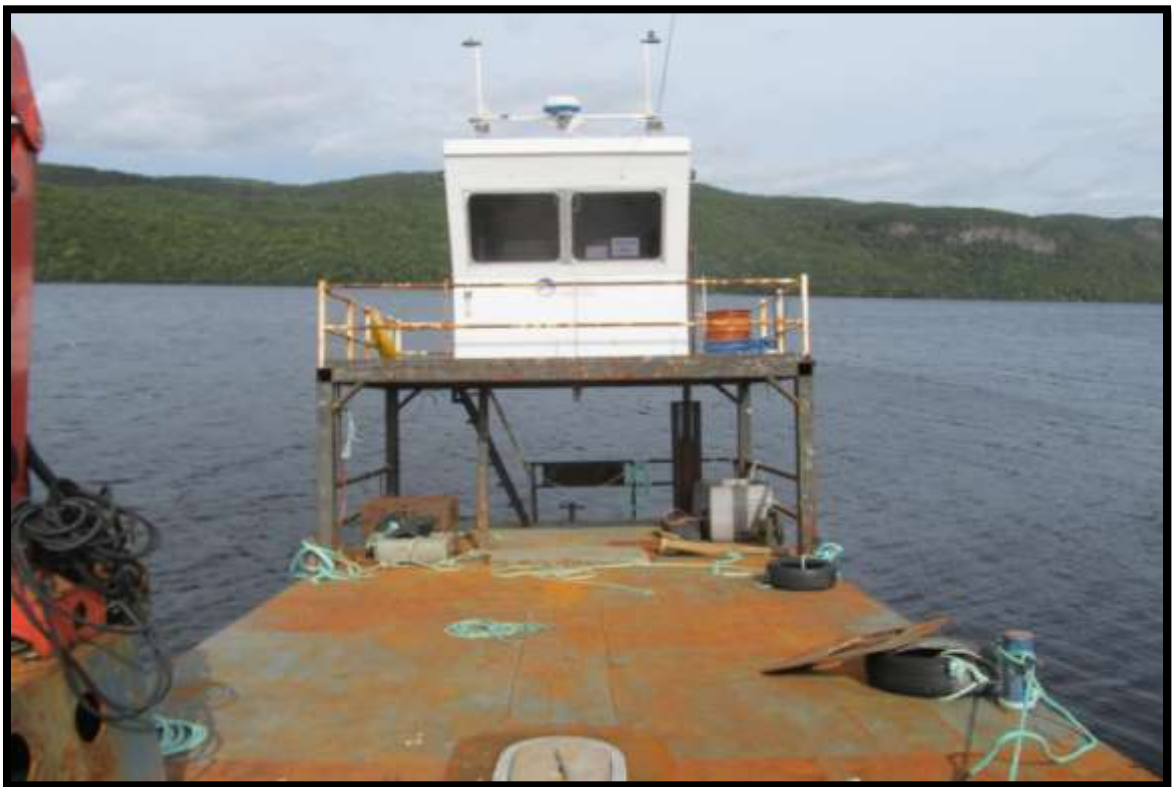
**MAIN DECK LOOKING AFT**

| <b>MAIN DECK</b> | Steel with minor dents, scrapes and corrosion / average |

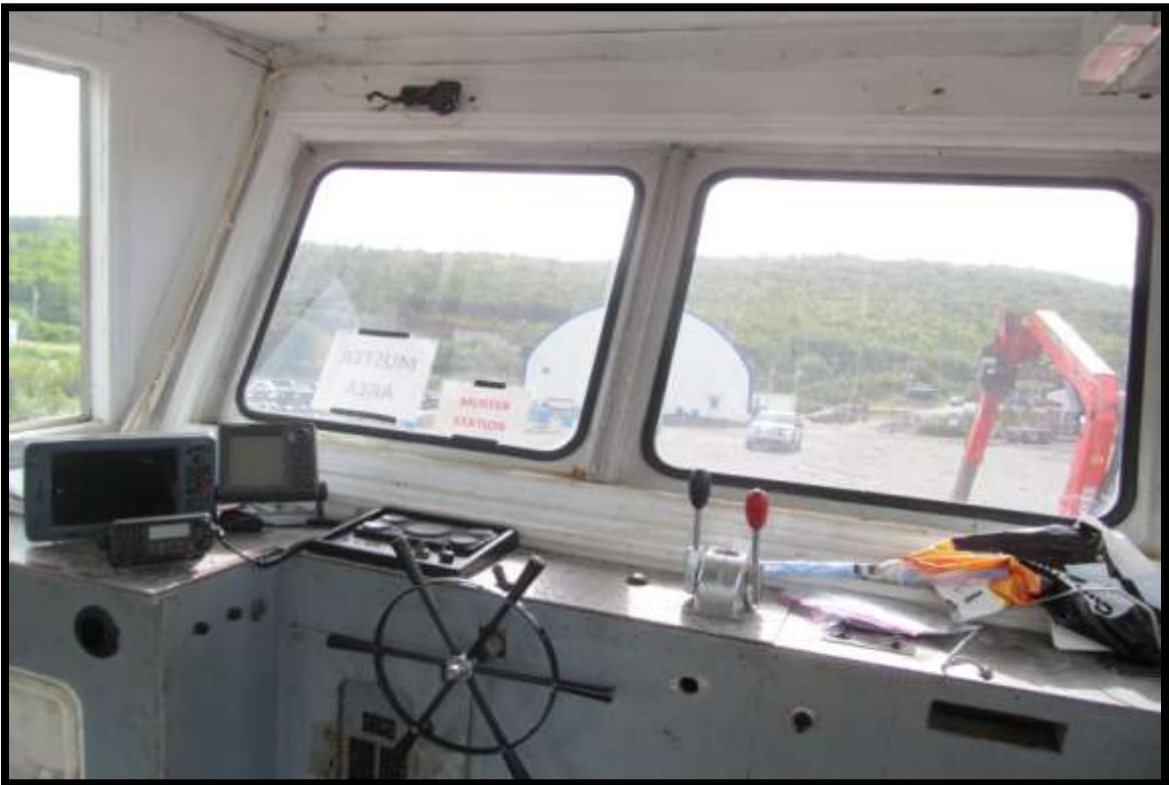
**WHEELHOUSE LOOKING FORWARD**

| | <u>DESCRIPTION</u> | <u>CONDITION</u> |
|---|---|---|
| <b>REMARKS:</b> Minimal amount of furnishing and equipment fitted. Wheelhouse compartment was found to be in average visual condition and suitable for the intended use. | | |

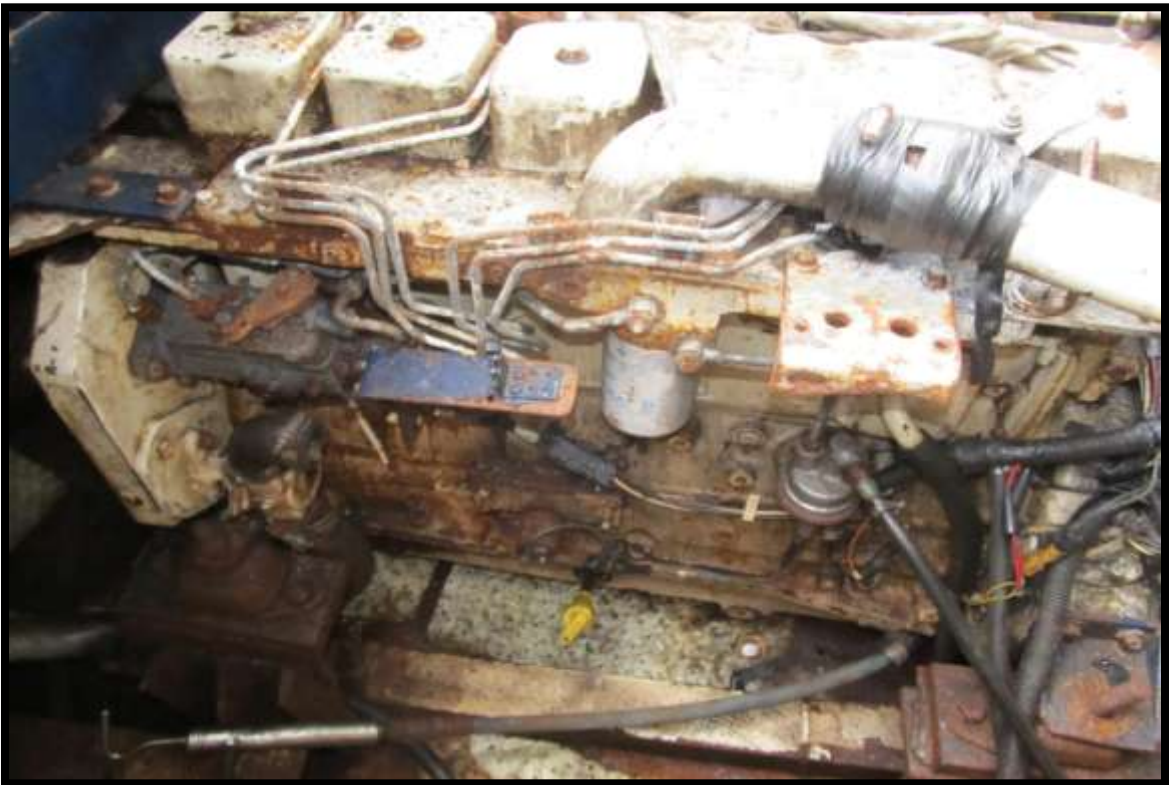
**MAIN ENGINE**

| <b><u>ITEM</u></b> | <b><u>COMMENTS / CONDITION</u></b> |
|---|---|
| REMARKS: All structure accessible at the time of survey was in average visual condition. Oil and water were noted in the engine room compartment. | |

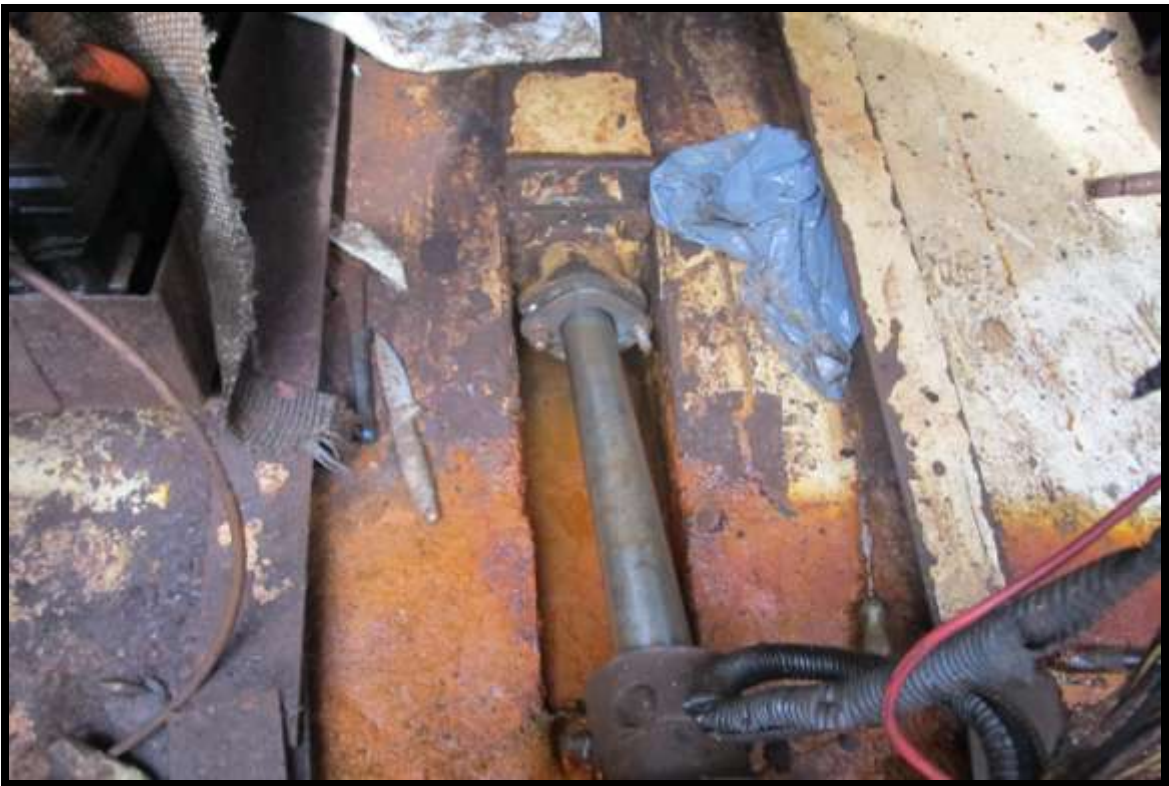
**SHAFTING**

| <b><u>ITEM</u></b> | <b><u>DESCRIPTION</u></b> | <b><u>CONDITION</u></b> |
|---|---|---|
| SHAFT SIZE | 2" stainless steel | Average |

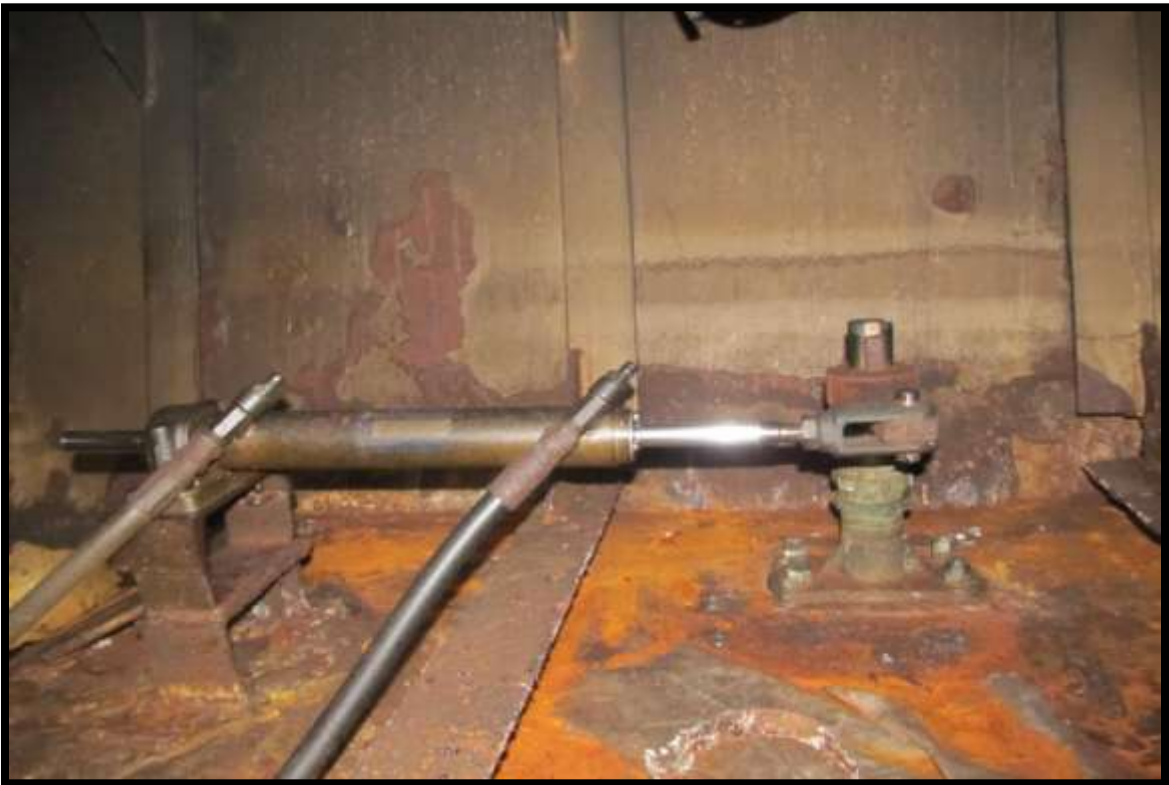
**STEERING GEAR**

| RUDDER STOCK SIZE | 1 ½" stainless steel | Average |

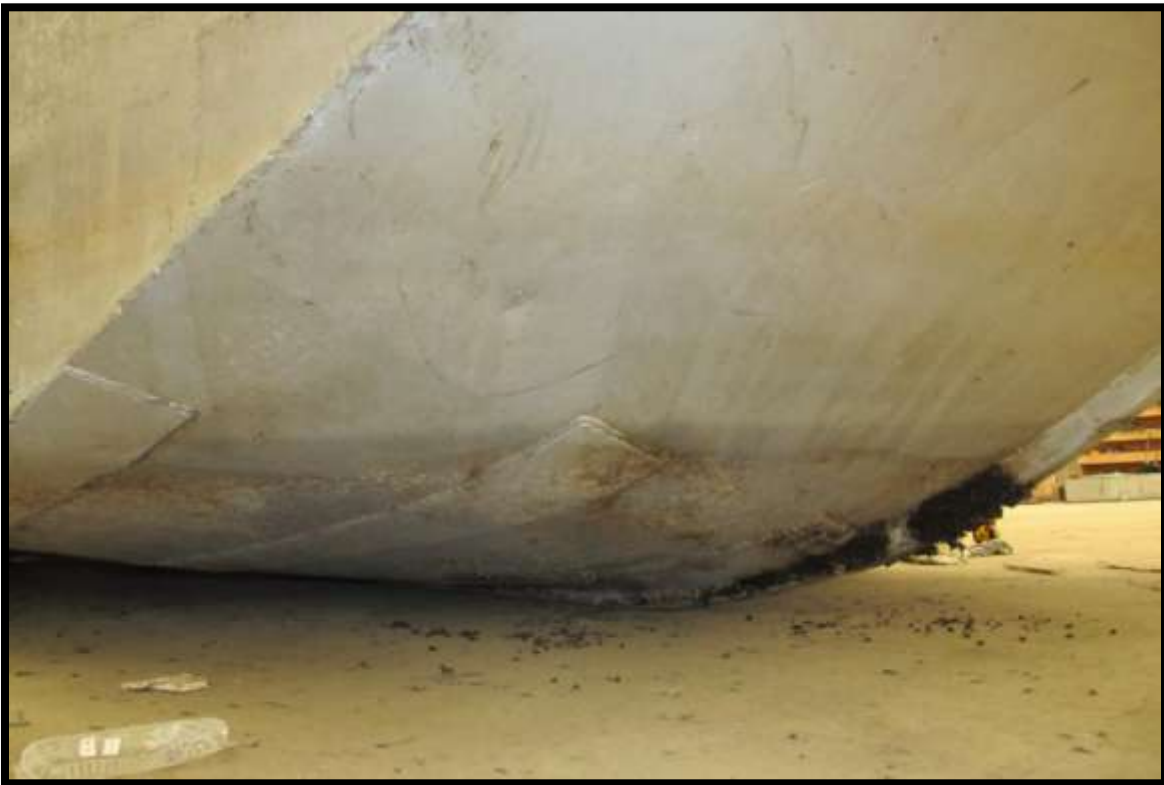
**BOW REPAIRS**

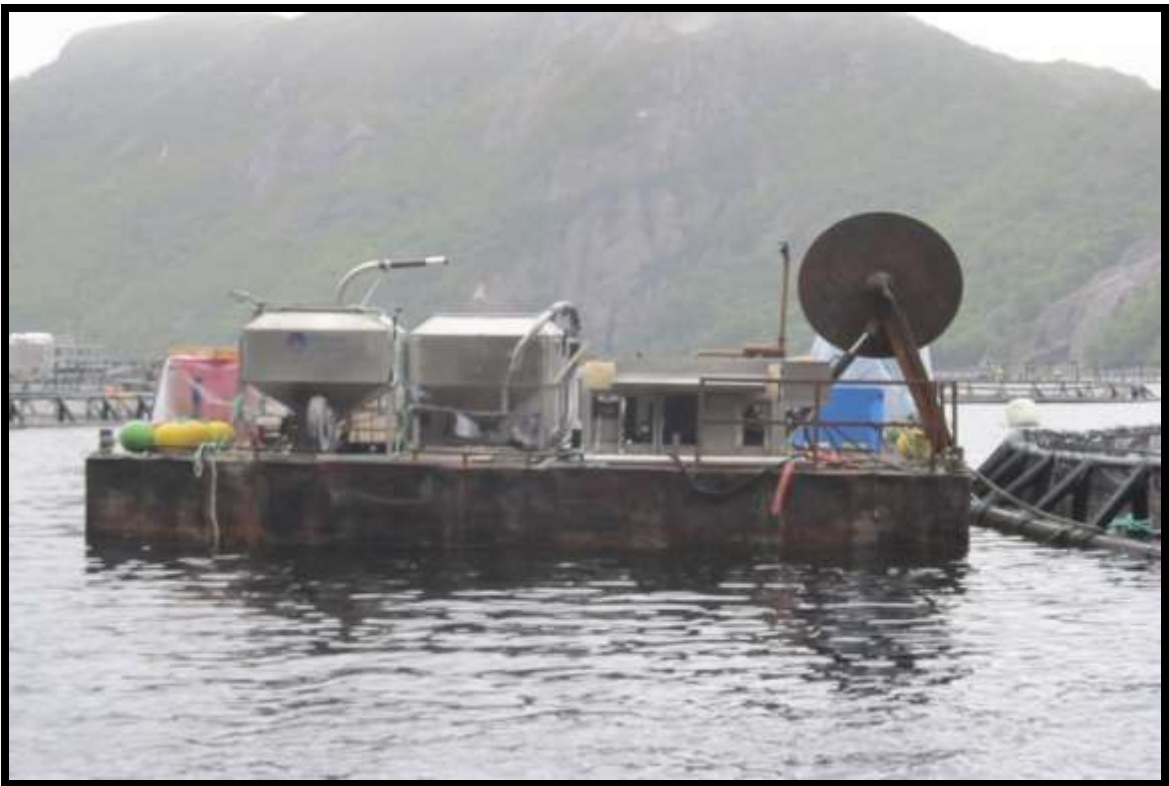
**STERN VIEW**

| <b>REMARKS:</b> The barge was afloat at the time of the survey; the underwater portion of the hull was inaccessible. All above water components (hull sides, bow, stern and deck) were found to be in a generally average visual condition. Damage typical of barge operations were noted on the bow, stern and hull sides - dents and scrapes. | |

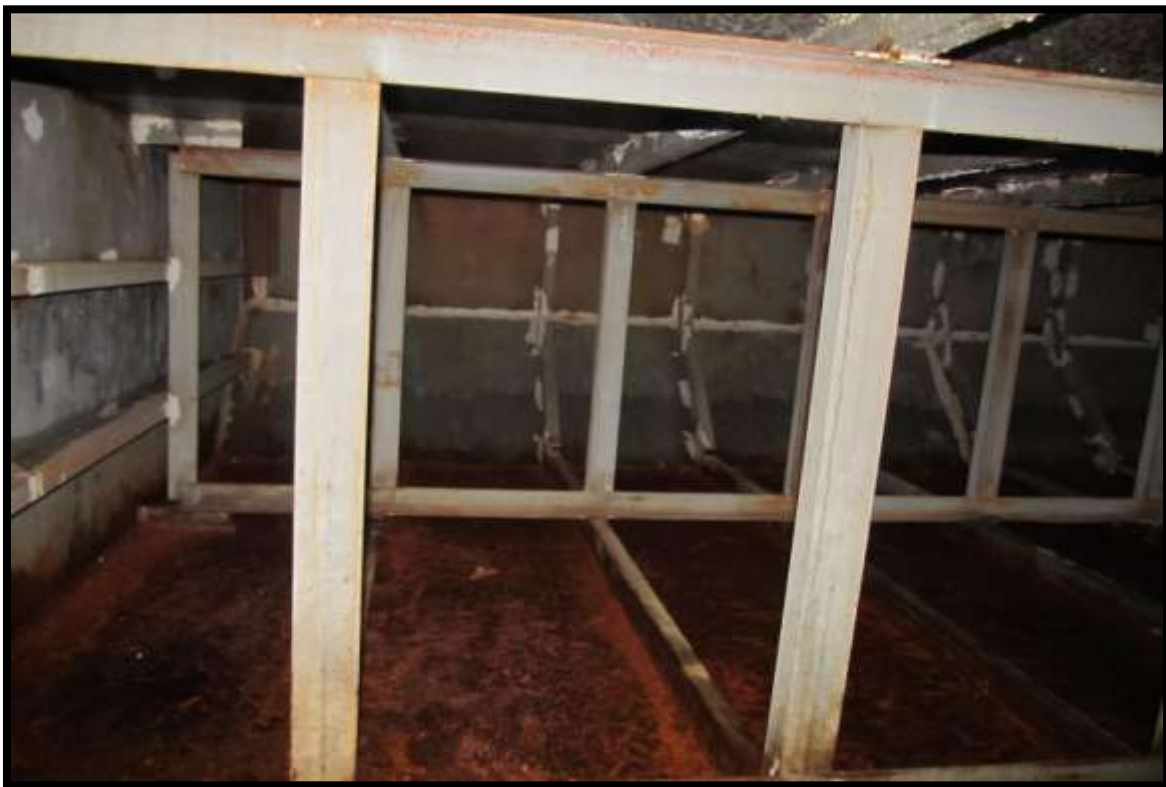
**FORWARD COMPARTMENT UNDER DECK STRUCTURE**

| <b><u>ITEM</u></b> | <b><u>COMMENTS / CONDITION</u></b> |
|---|---|
| <b>REMARKS:</b> Typical structural arrangement for design and intended use of barge. Compartments were not entered; however, a visual survey was completed from the hatch opening. No major damage was noted on barge under deck structure. | |

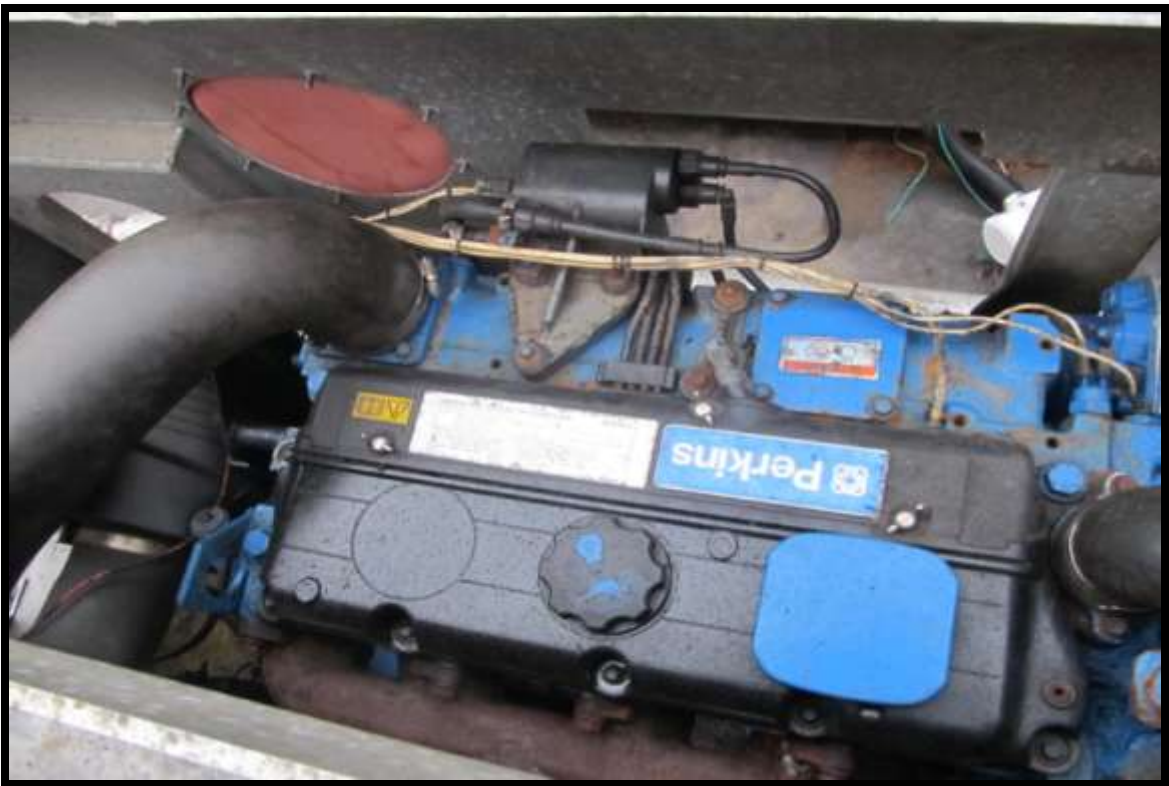
ENGINE

| <b>REMARKS:</b> Diesel engine is part of an hydraulic power pack for barge hydraulic systems. Engine was found to be in average visual condition. | |

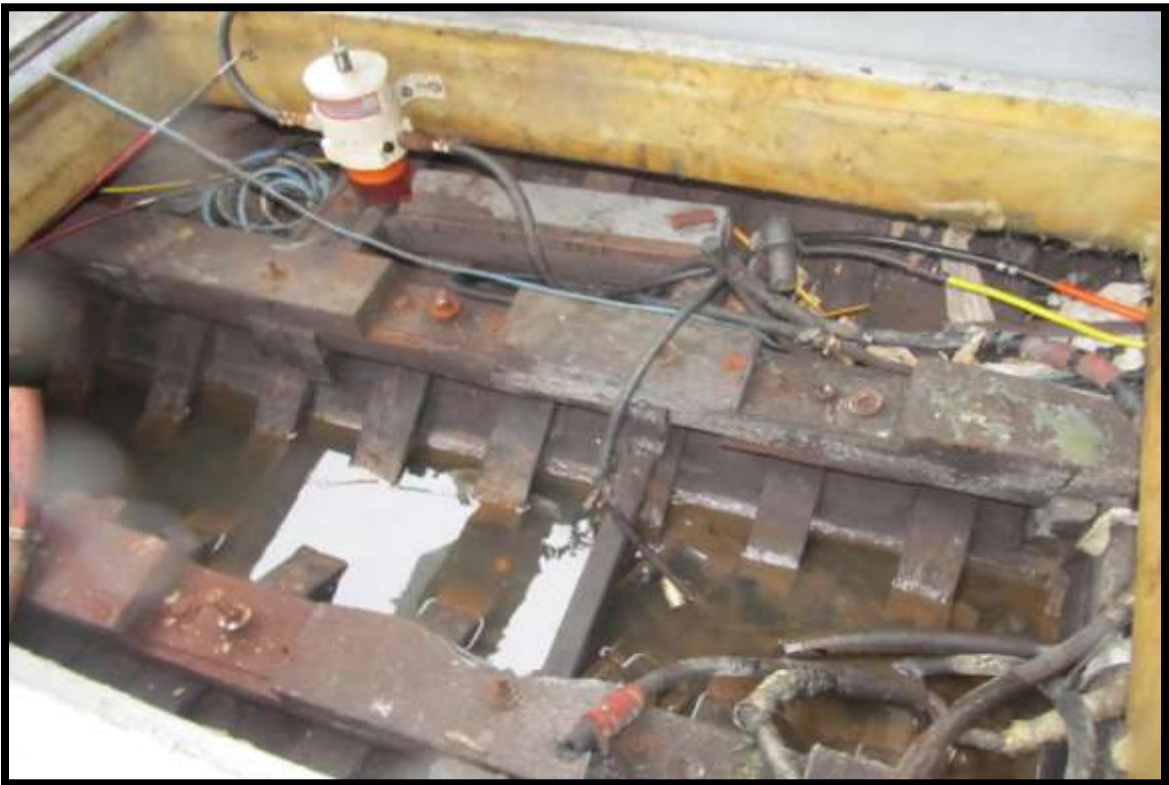
**ENGINE COMPARTMENT**

| BILGES | Water noted in engine room compartment |

| ENGINE ROOM | Located beneath main deck, aft of wheelhouse. Average visual condition. Main engine & transmission removed at time of survey. |

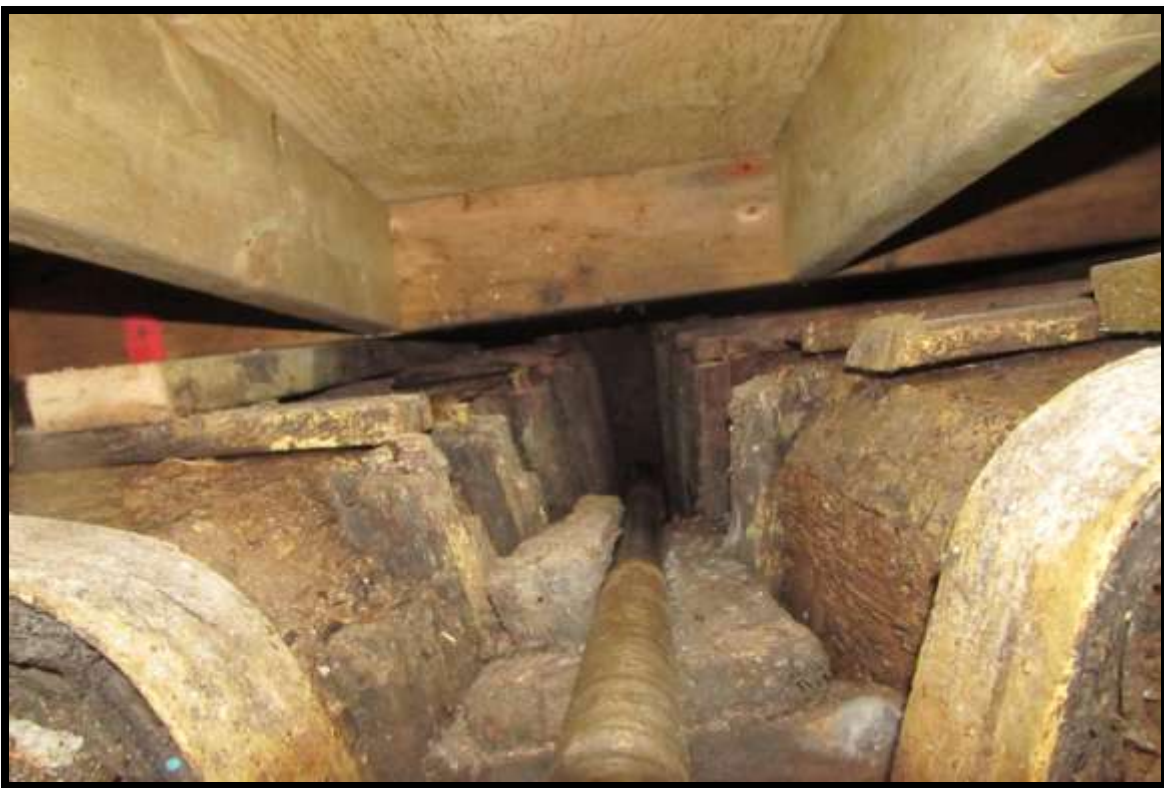
**SHAFT TRENCH AND MAIN DECK STRUCTURE**

| <b>REMARKS:</b> Typical interior arrangement for vessels age and design. In general, the hull structure was found to be in average visual condition where visible. Rot was evident on hull frames in the area of the vessels shaft line. | |

Since the vessel was afloat at the time of the survey, the exterior underwater hull was inaccessible. The exterior hull, decks, deckhouse/wheelhouse were all found to be in fair to average visual condition and without major damage. The vessels interior was found to be in an overall average visual condition. Some rot noted on hull frames in shaft trench.

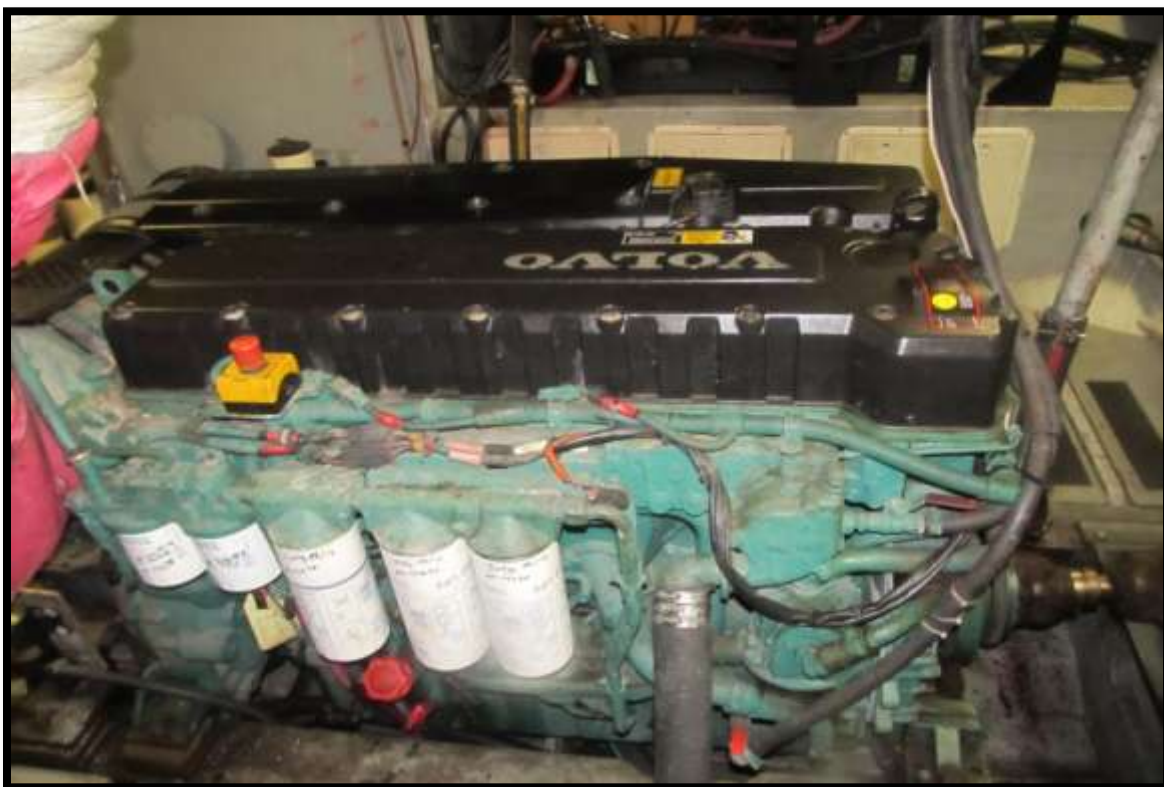
**MAIN ENGINE**

| <b>REMARKS:</b> Main engine was in above average visual condition. | |

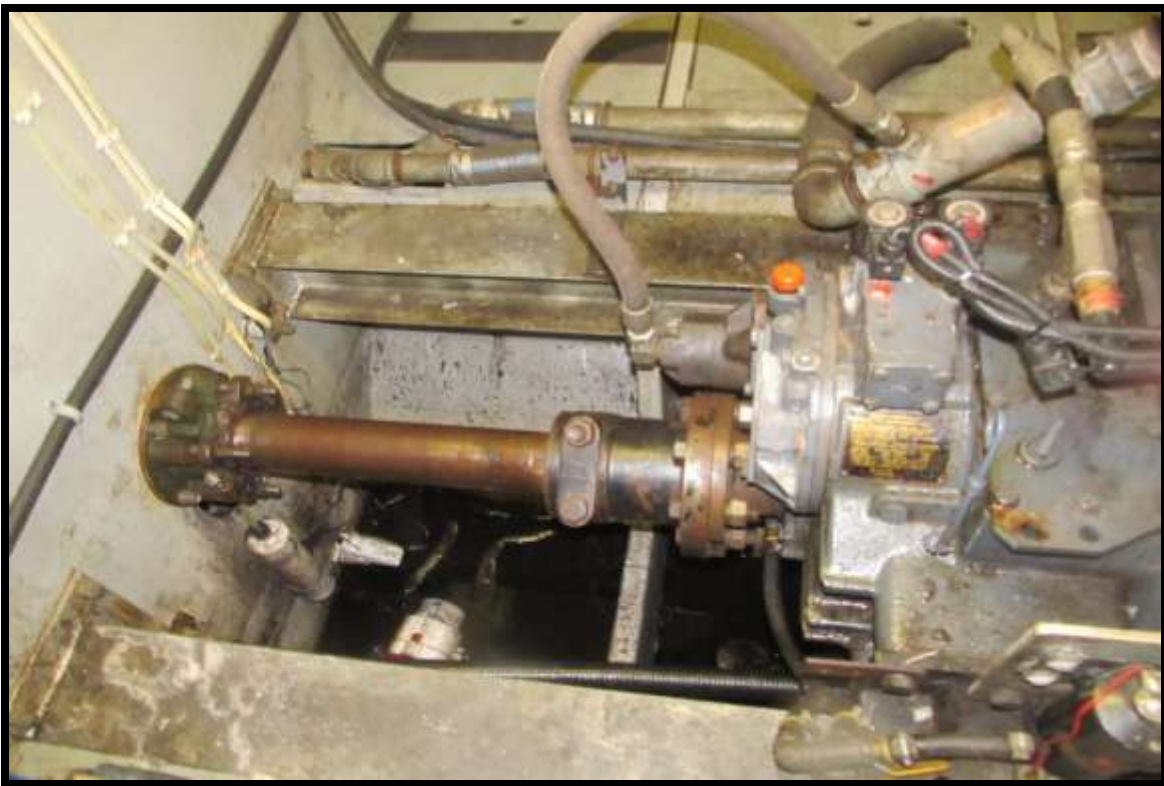
**GEAR BOX, SHAFTING AND BULKHEAD GLAND**

| <b>REMARKS:</b> Transmission was in above average visual condition. | |

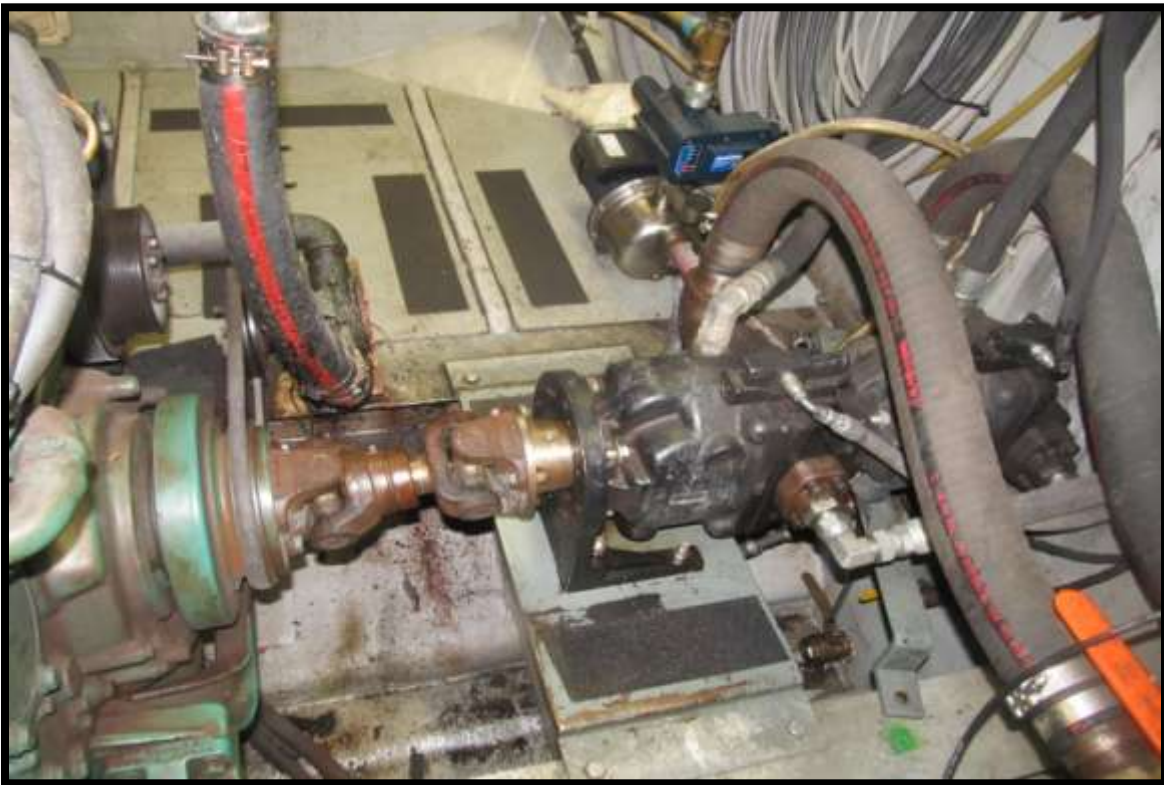
**HYDRAULICS**

| <b><u>ITEM</u></b> | <b><u>DESCRIPTION</u></b> | <b><u>CONDITION</u></b> |
|---|---|---|
| <b>REMARKS:</b> Typical hydraulic system fitted for vessels intended operation. Hydraulic system was in above average visual condition. | | |

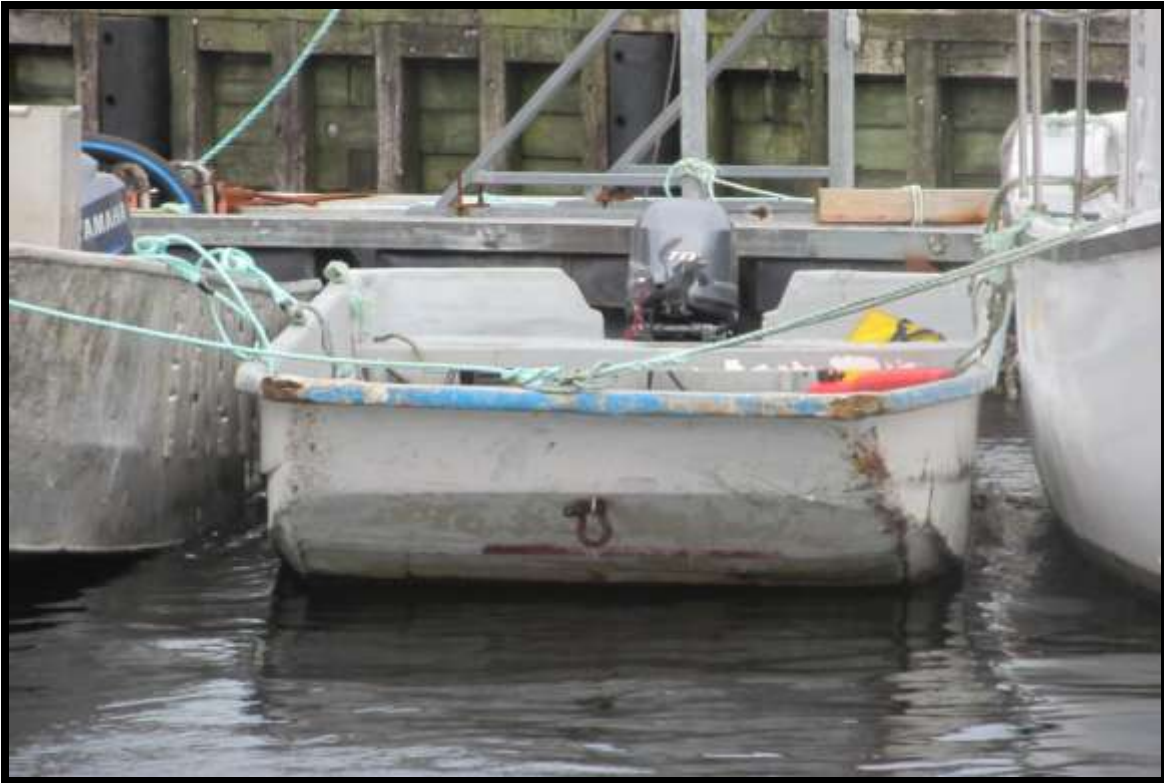
Vessel was surveyed in the water while moored between two vessels at the wharf located in Hermitage, NL. Since the vessel was afloat at the time of the survey, the underwater hull was inaccessible. Above water hull (where visible) was found to be in fair to average visual condition. Bow was noted to be damaged on the port and starboard.

**BOW VIEW**

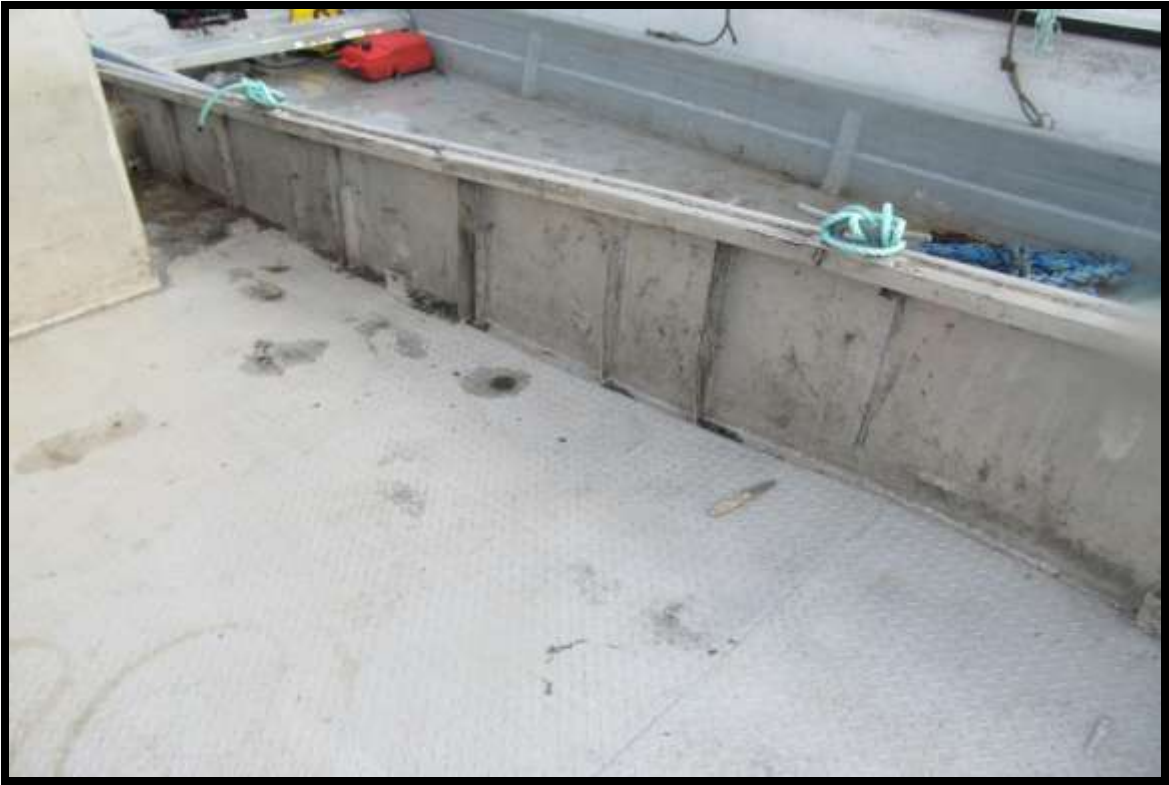
| <u><b>ITEM</b></u> | <u><b>COMMENTS / CONDITION</b></u> |
|---|---|
| <b>BULWARKS</b> | Aluminum with minor damage on bulwark top / fair to average |

**STARBOARD SIDE BULWARKS**

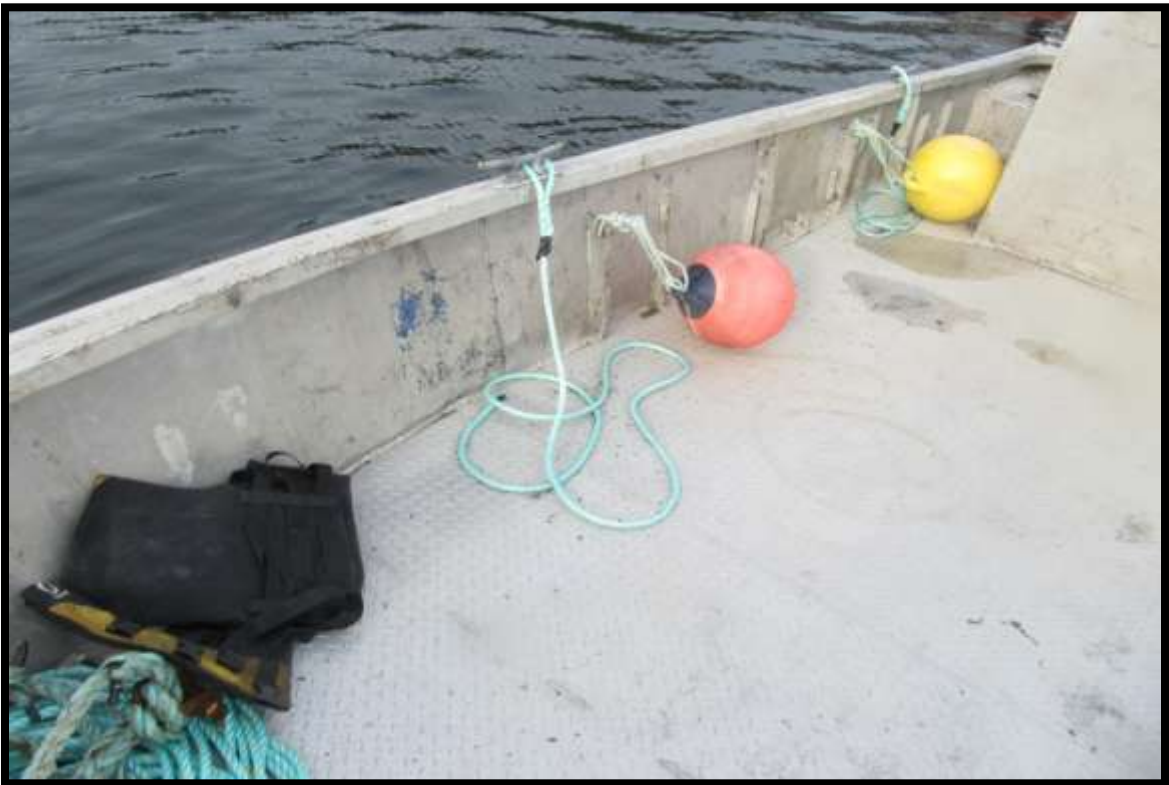
**PORT SIDE BULWARKS**
